Post Installation Report

Ringshall Parish Council

Ringshall Village Hall

Inspection Ref: 1901313

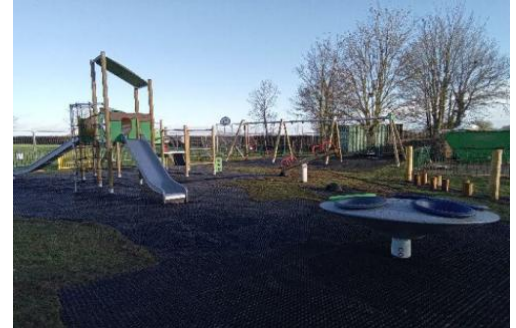
Item: Site General
Manufacturer: Not Applicable
Surface Type: N/A
Item Quantity: 1
Equipment Compliance: N/A
Surface Area Compliance: N/A

It is recommended that signage, with information including the site address, contact information for maintenance issues and emergency contact details are provided for the facility - Provide in accordance with the recommendations

NOTE: The landscaping was incomplete at the time of inspection - Complete the landscaping

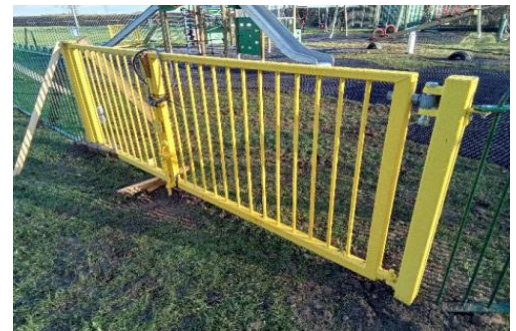
Item: Gate - Combination
Manufacturer: I.A.E. Fencing
Surface Type: Grass
Item Quantity: 1
Equipment Compliance: N/A
Surface Area Compliance: N/A

A number of fixing(s) have worked loose - Secure all loose fixings

The gate/s was / were locked or secured at the time of the inspection and a full inspection could not be undertaken - Complete inspection of gate/s when re-opened

There is no padlock on the maintenance gate - Provide a padlock to secure the gate

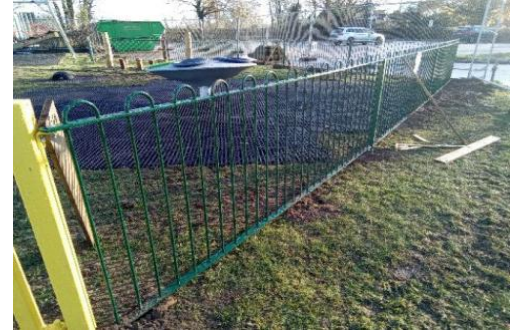
Item: Fence - Bow Top
Manufacturer: Not Identified
Surface Type: Grass
Item Quantity: 1
Equipment Compliance: N/A
Surface Area Compliance: N/A

There is some damage to the fence sections - Refer to the contractor

Shear nuts have not been fully tightened and are still present on fixings - Tighten heads on nuts to shear off and secure

Supports are still present - Remove

The paintwork is worn - Refer to the contractor

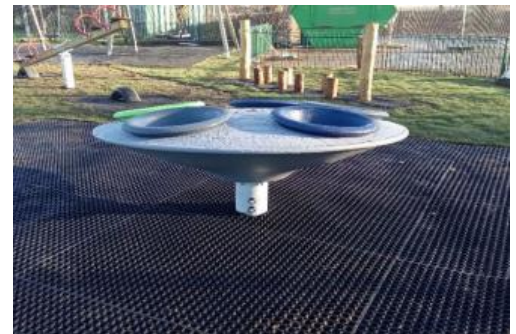
Item: Roundabout
Manufacturer: Kompan Ltd
Surface Type: Grass Matrix Tiles
Item Quantity: 1
Equipment Compliance: Yes
Surface Area Compliance: Yes

This item is satisfactory - no work required -

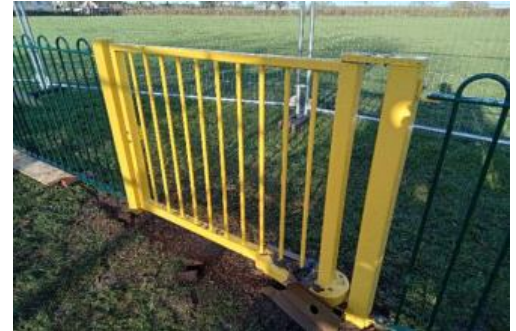
Item: Gate - Self Closing
Manufacturer: I.A.E. Fencing
Surface Type: Grass
Item Quantity: 1
Equipment Compliance: N/A
Surface Area Compliance: N/A

This item is satisfactory - no work required -

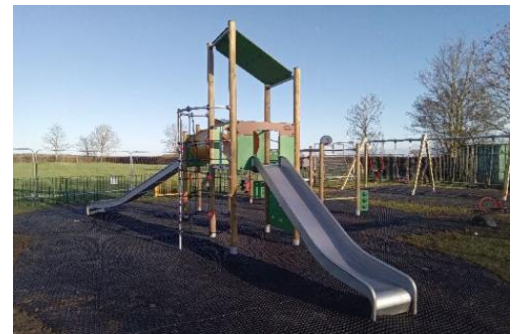
Item: Multi Play (Junior)
Manufacturer: Kompan Ltd
Surface Type: Grass Matrix Tiles
Item Quantity: 1
Equipment Compliance: Yes
Surface Area Compliance: Yes

There are two bolt cap covers missing or damaged on the item - Replace missing or damaged bolt cap covers

There is/are bolt cap covers missing or damaged on the slide starting section - Replace missing or damaged bolt cap covers

A connection cover is unsecured on the bridge - Secure

There are ten bolt cap covers missing or damaged on the climber - Replace missing or damaged bolt cap covers

The slide is predominately south facing and will catch the majority of the sun's heat during the day. Slide surfaces can become very warm during periods of sustained sunny weather - Monitor - No remedial work recommended

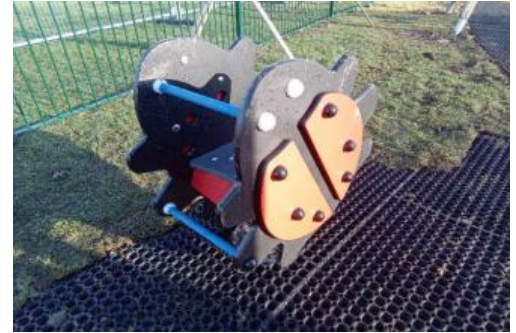
Item: Spring Ladybird
Manufacturer: Kompan Ltd
Surface Type: Mixed Surface
Item Quantity: 1
Equipment Compliance: Yes
Surface Area Compliance: Yes

This item is satisfactory - no work required -

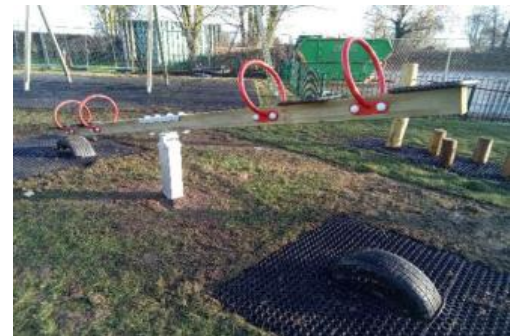
Item: See Saw
Manufacturer: Kompan Ltd
Surface Type: Mixed Surface
Item Quantity: 1
Equipment Compliance: Yes
Surface Area Compliance: Yes

This item is satisfactory - no work required -

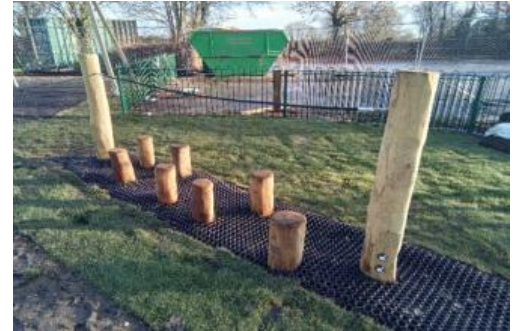
Item: Stepping Posts Timber
Manufacturer: Kompan Ltd
Surface Type: Mixed Surface
Item Quantity: 1
Equipment Compliance: Yes
Surface Area Compliance: Yes

This item is satisfactory - no work required -

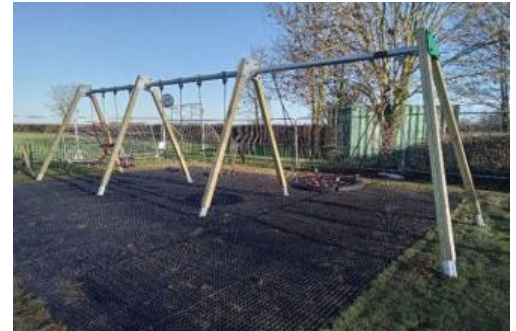
Item: 3 Bay Swing
Manufacturer: Kompan Ltd
Surface Type: Grass Matrix Tiles
Item Quantity: 1
Equipment Compliance: Yes
Surface Area Compliance: Yes

This item is satisfactory - no work required -

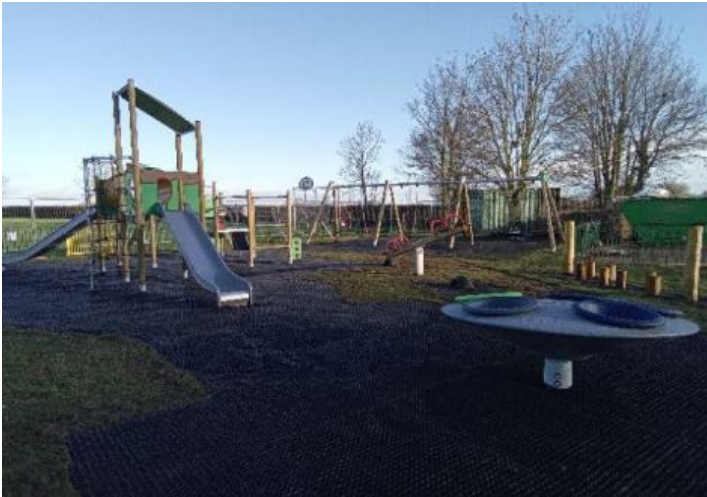
5 - Very Low Risk (Finding 1)

Finding: It is recommended that signage, with information including the site address, contact information for maintenance issues and emergency contact details are provided for the facility

Action: Provide in accordance with the recommendations

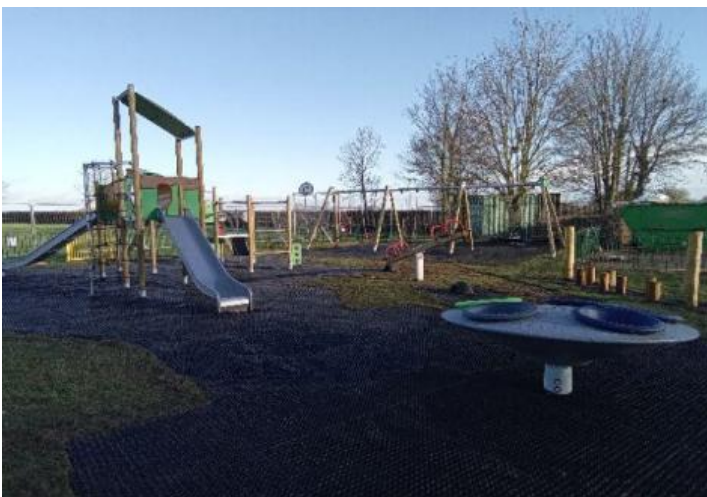
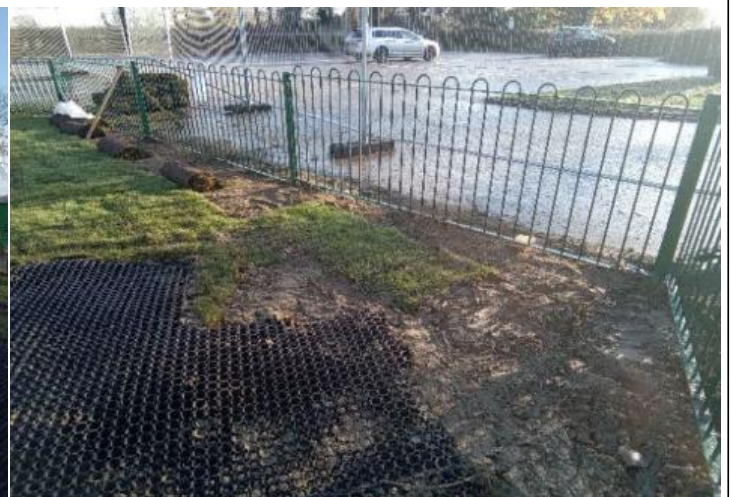
0 - Risk Assessment not Undertaken (Finding 2)

Finding: NOTE: The landscaping was incomplete at the time of inspection

Action: Complete the landscaping

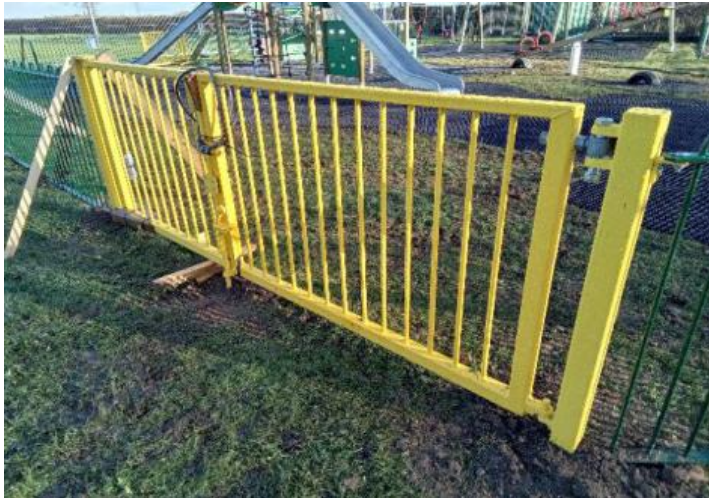
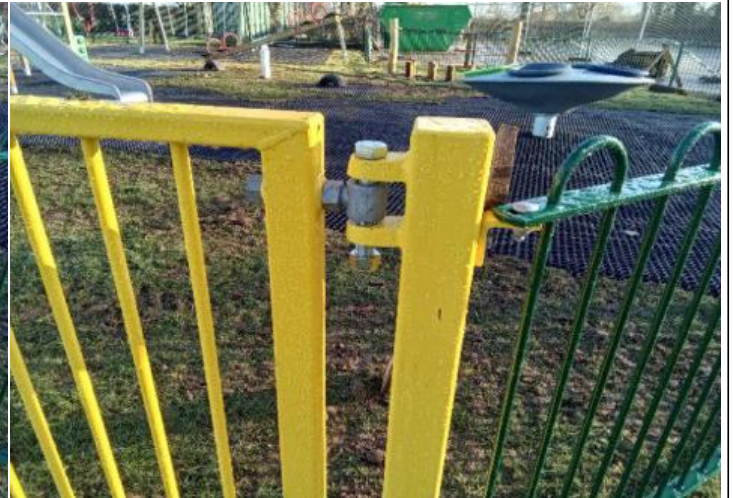
i 6 - Low Risk (Finding 1)

Finding: A number of fixing(s) have worked loose

Action: Secure all loose fixings

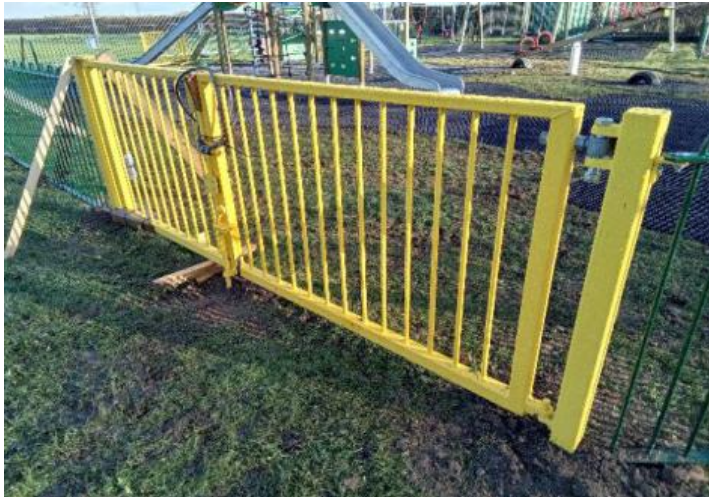
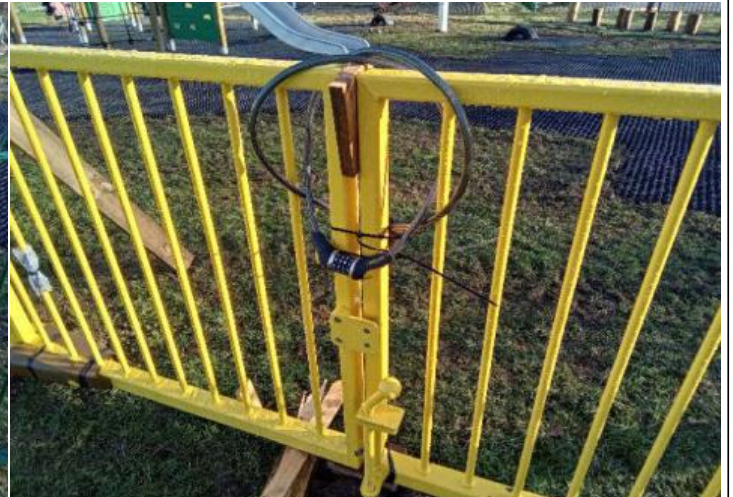
i 0 - Risk Assessment not Undertaken (Finding 2)

Finding: The gate/s was / were locked or secured at the time of the inspection and a full inspection could not be undertaken

Action: Complete inspection of gate/s when re-opened

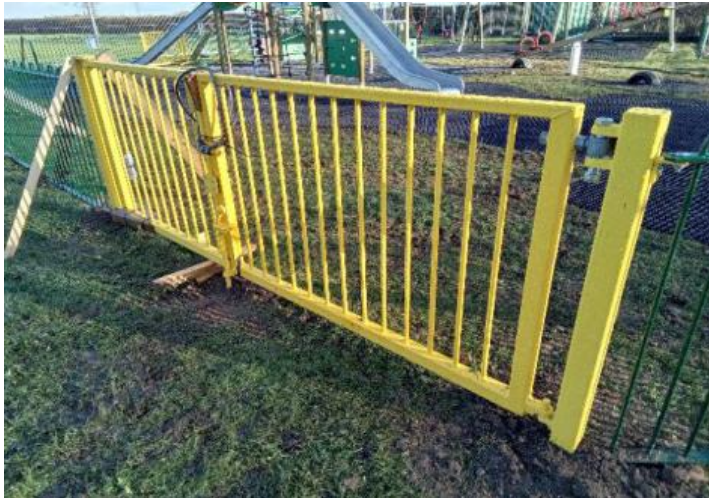
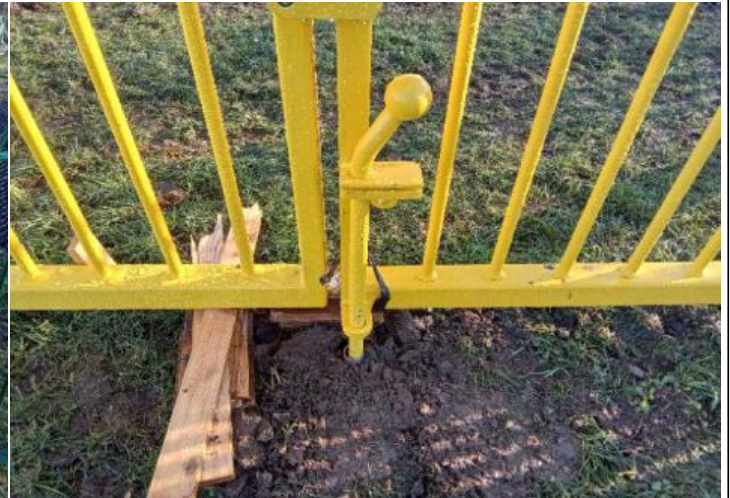
i 6 - Low Risk (Finding 3)

Finding: There is no padlock on the maintenance gate

Action: Provide a padlock to secure the gate

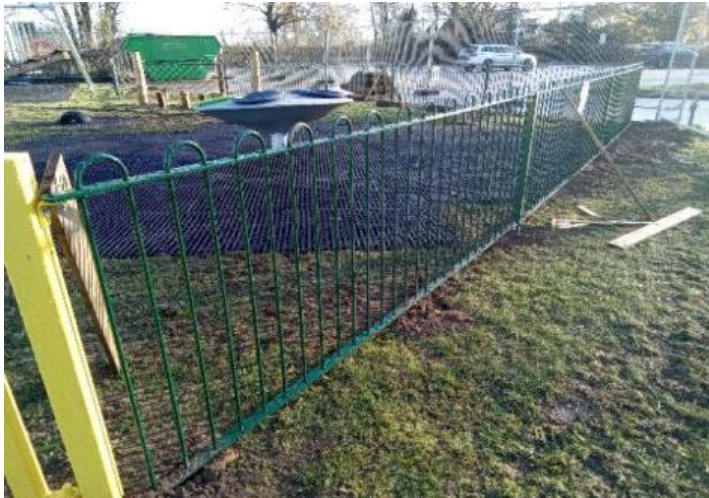
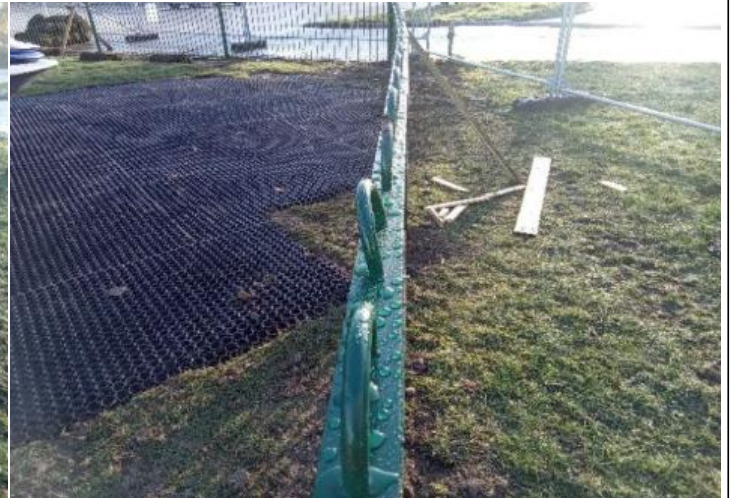
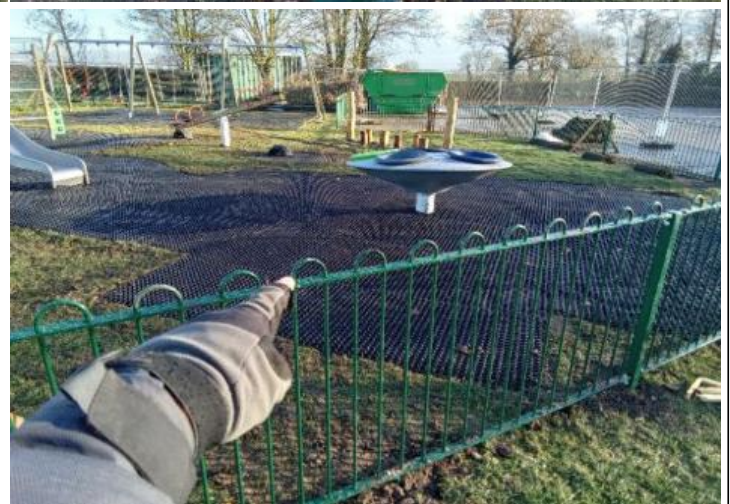
i 4 - Very Low Risk (Finding 1)

Finding: There is some damage to the fence sections

Action: Refer to the contractor

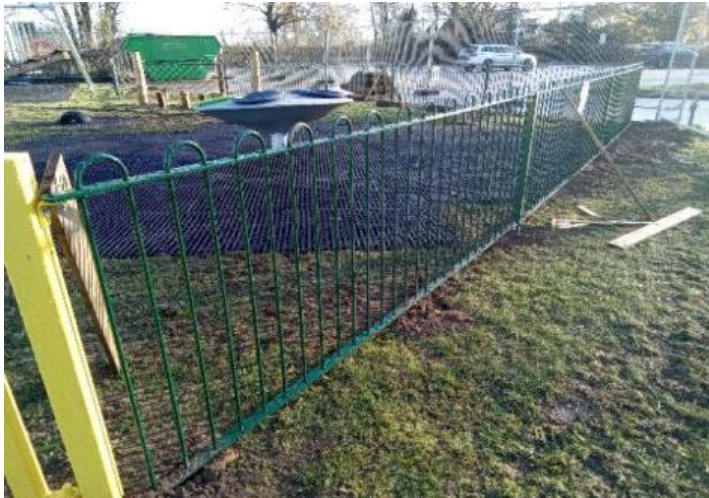
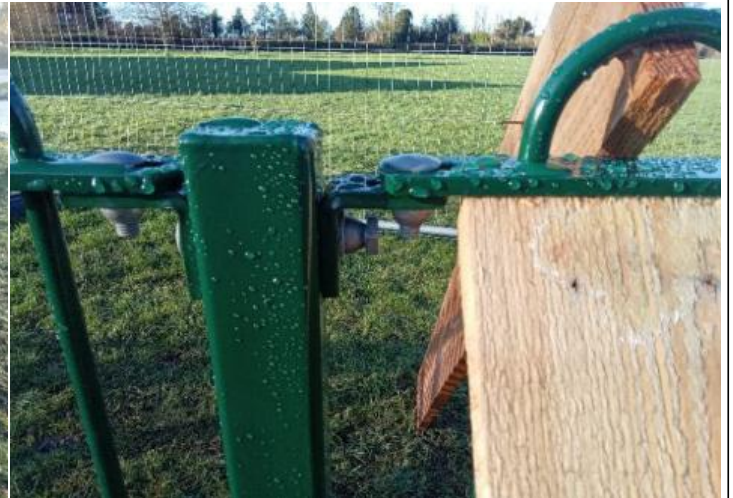
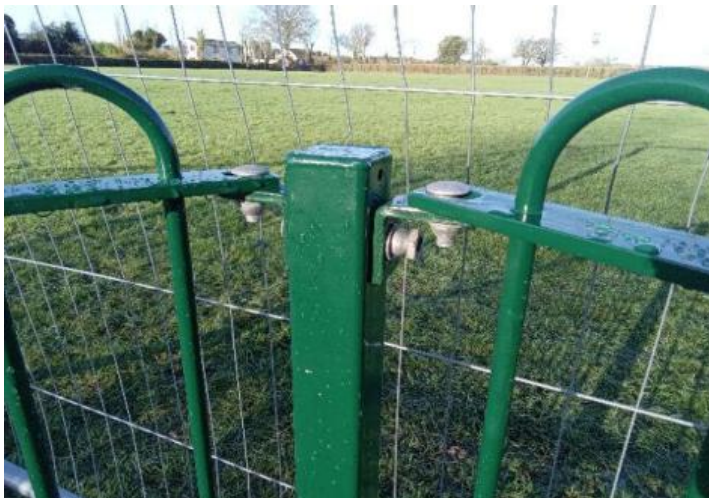
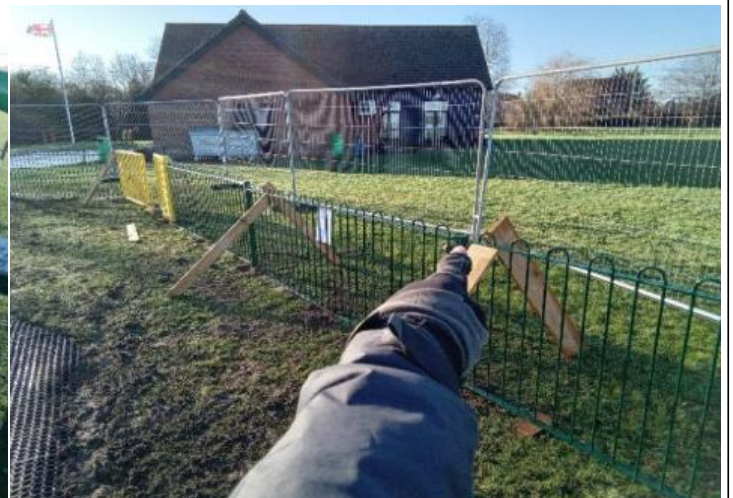
i 4 - Very Low Risk (Finding 2)

Finding: Shear nuts have not been fully tightened and are still present on fixings

Action: Tighten heads on nuts to shear off and secure

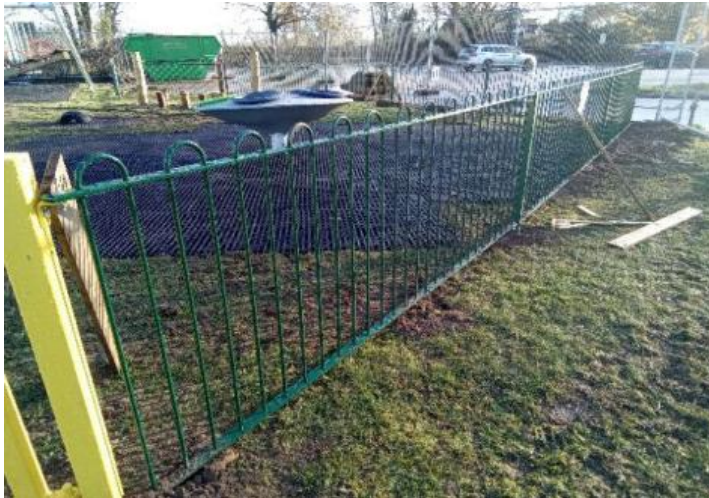
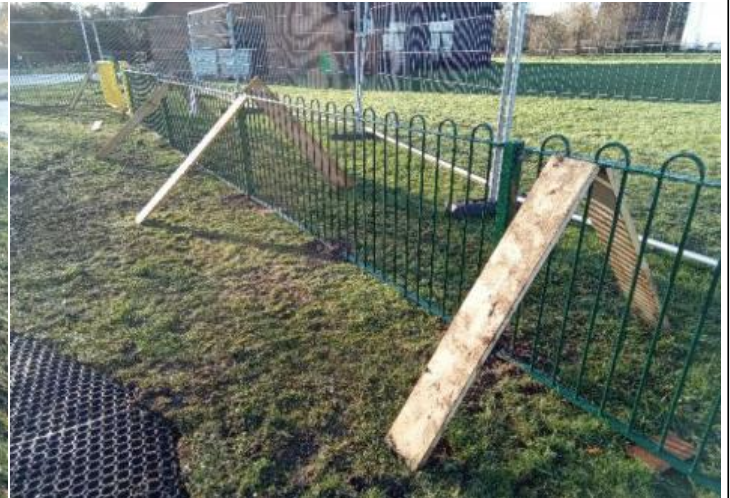
i 8 - Low Risk (Finding 3)

Finding: Supports are still present

Action: Remove

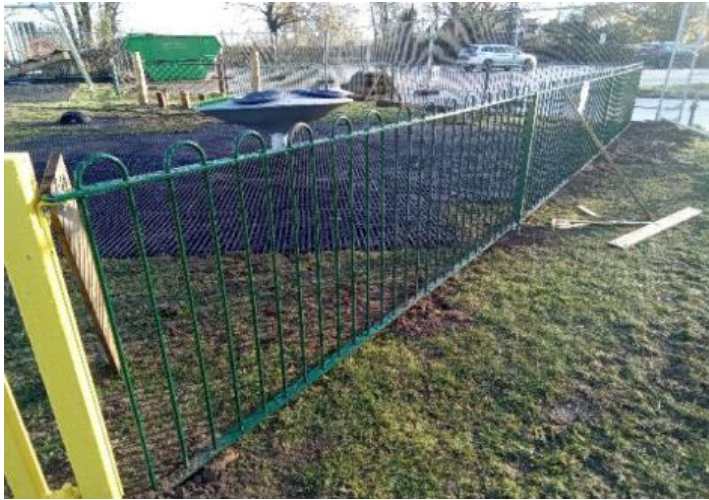
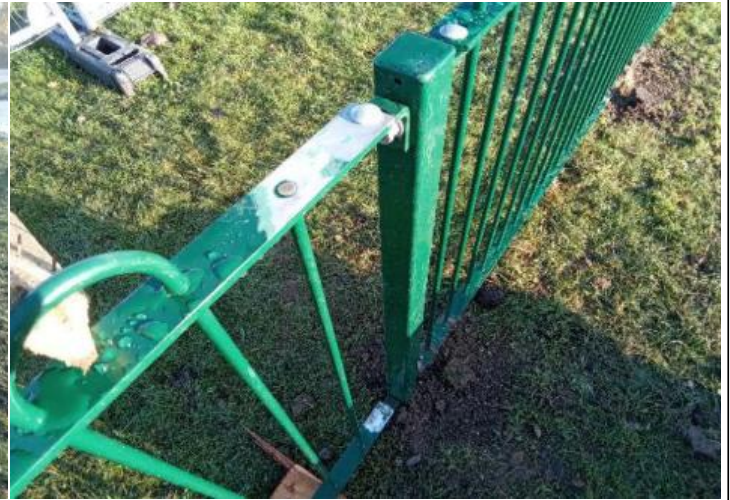
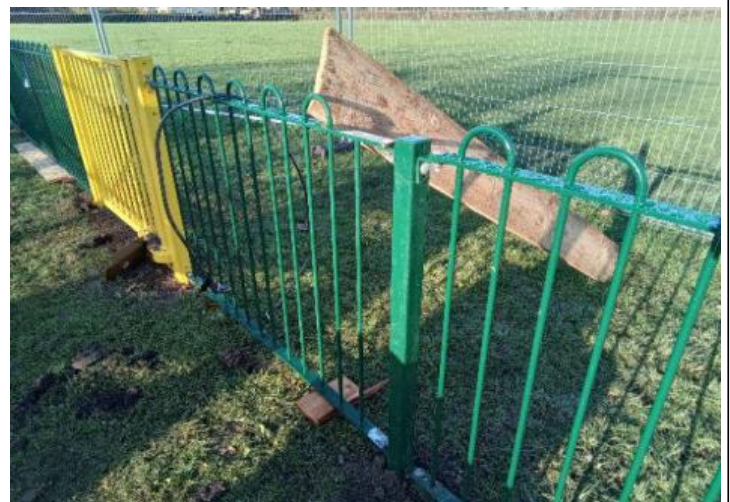
i 4 - Very Low Risk (Finding 4)

Finding: The paintwork is worn

Action: Refer to the contractor

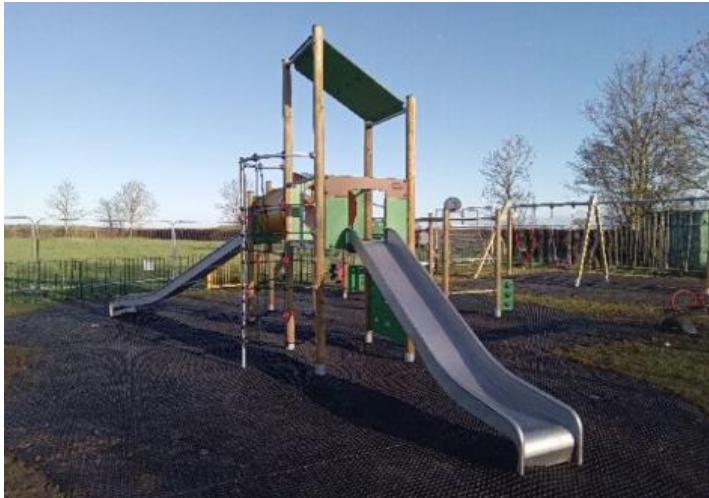
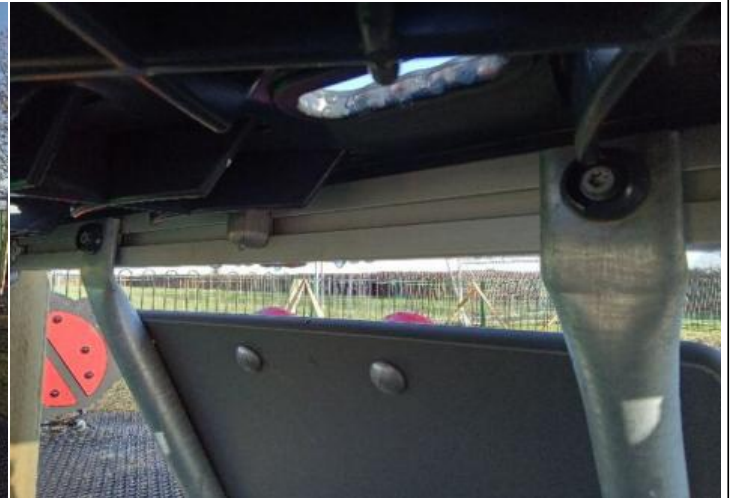
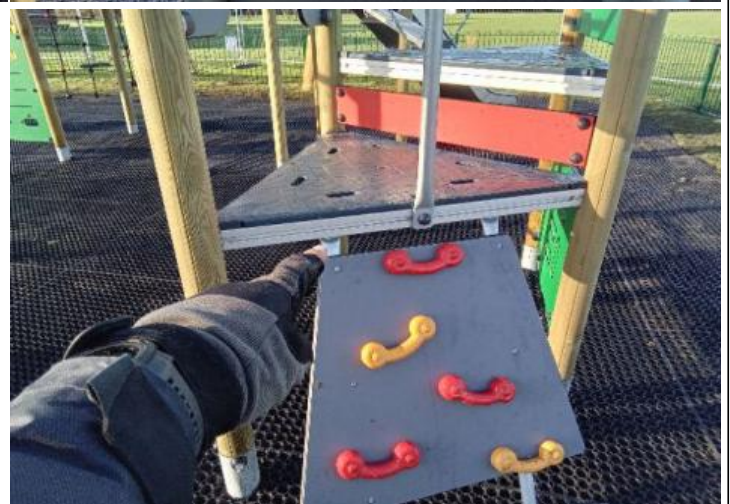
i 4 - Very Low Risk (Finding 1)

Finding: There are two bolt cap covers missing or damaged **Action:** Replace missing or damaged bolt cap covers on the item

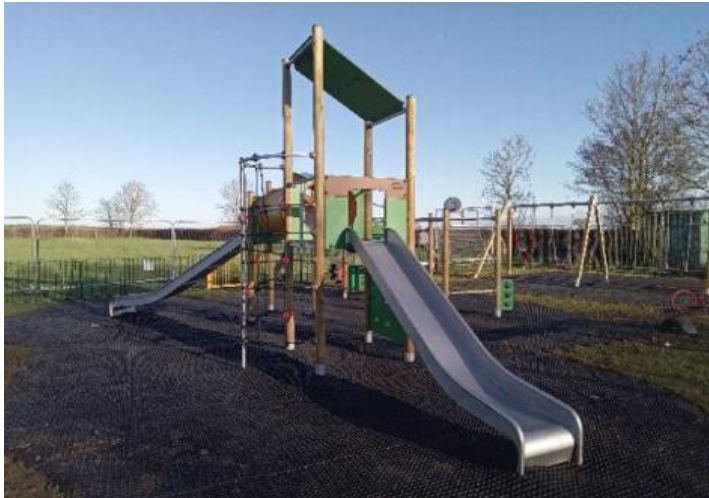
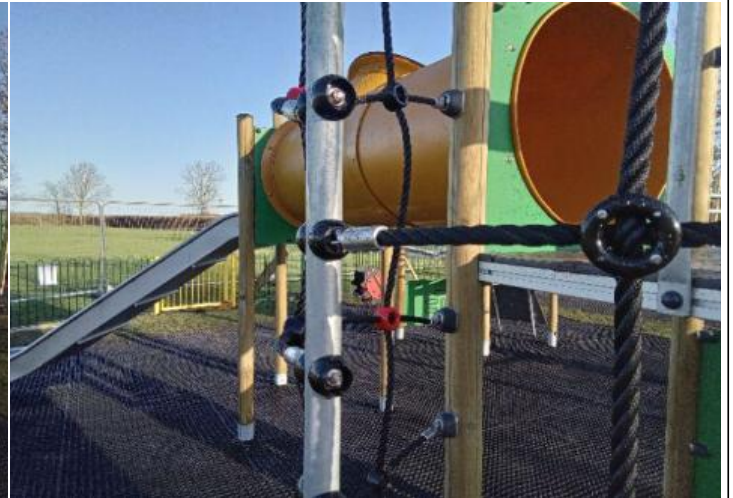
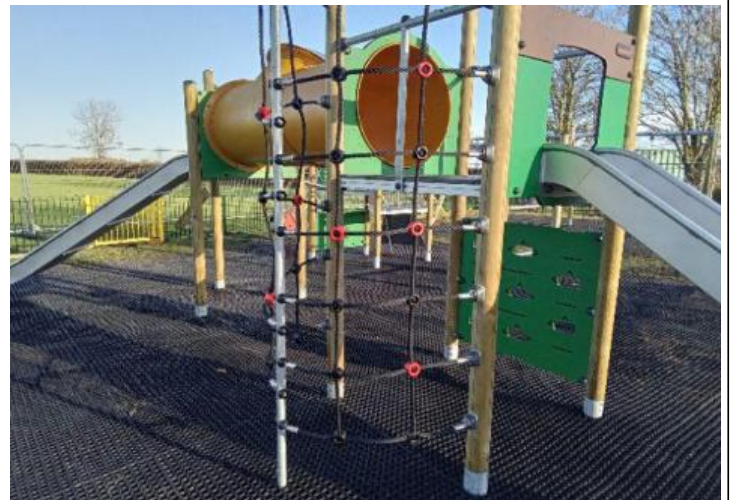
i 4 - Very Low Risk (Finding 2)

Finding: There are ten bolt cap covers missing or damaged on the climber
Action: Replace missing or damaged bolt cap covers

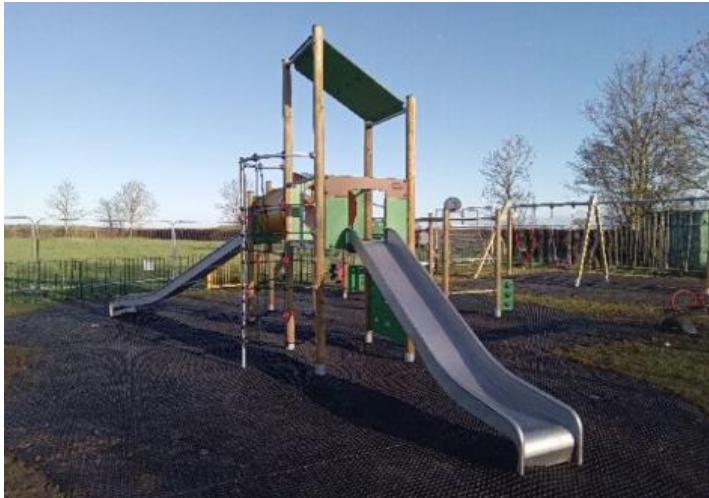
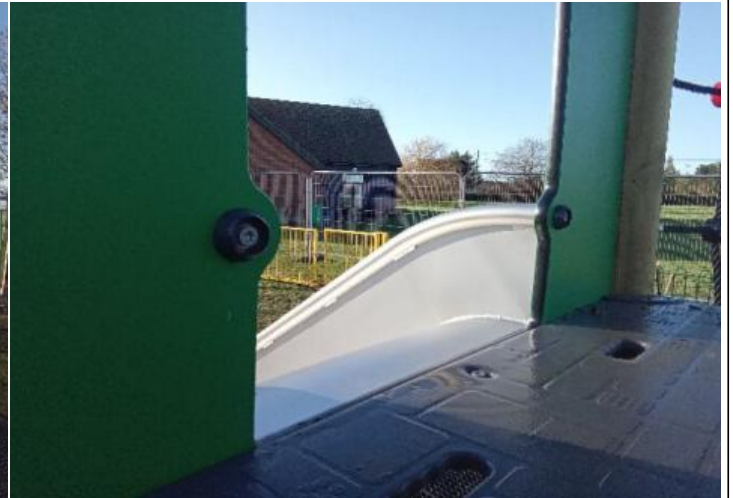
i 4 - Very Low Risk (Finding 3)

Finding: There is/are bolt cap covers missing or damaged on the slide starting section

Action: Replace missing or damaged bolt cap covers

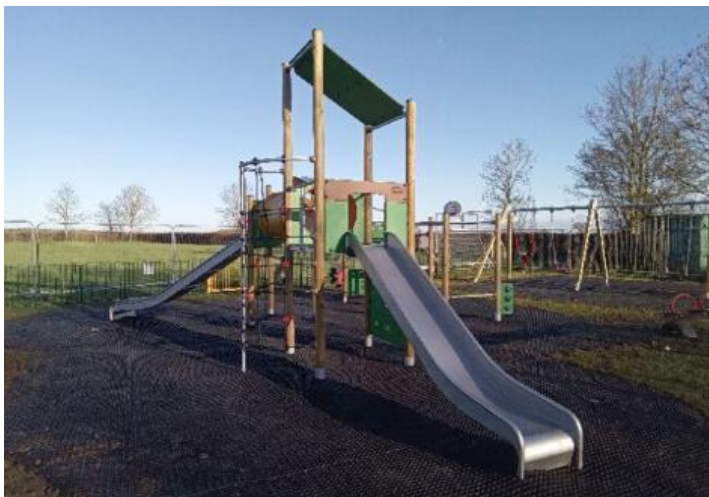
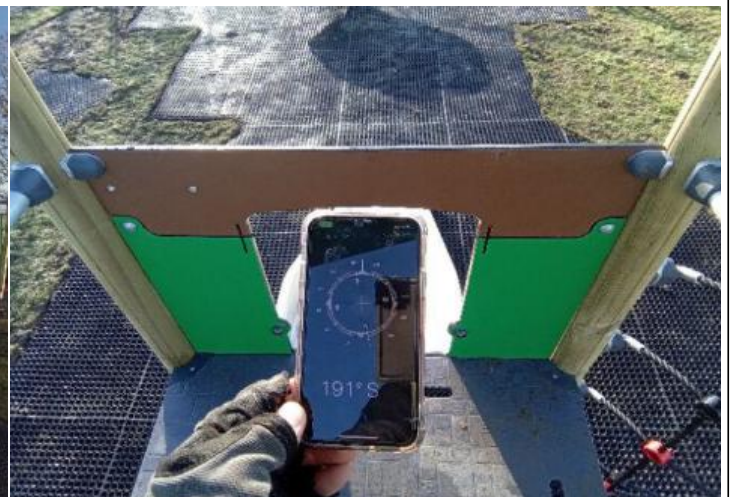
i 6 - Low Risk (Finding 4)

Finding: The slide is predominately south facing and will catch the majority of the sun's heat during the day. Slide surfaces can become very warm during periods of sustained sunny weather

Action: Monitor - No remedial work recommended

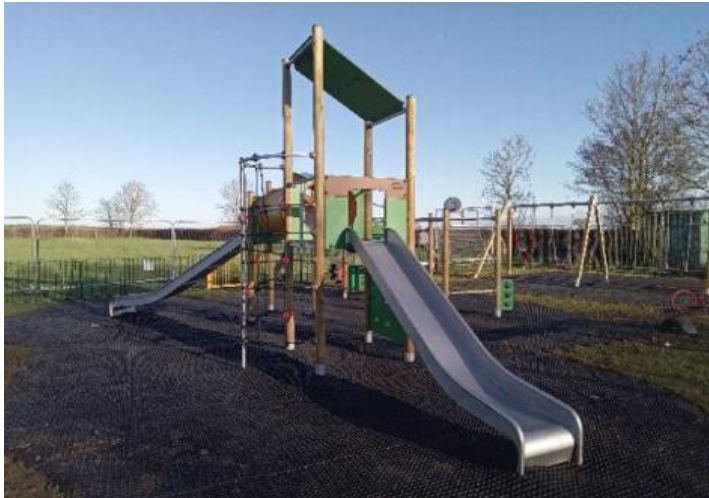
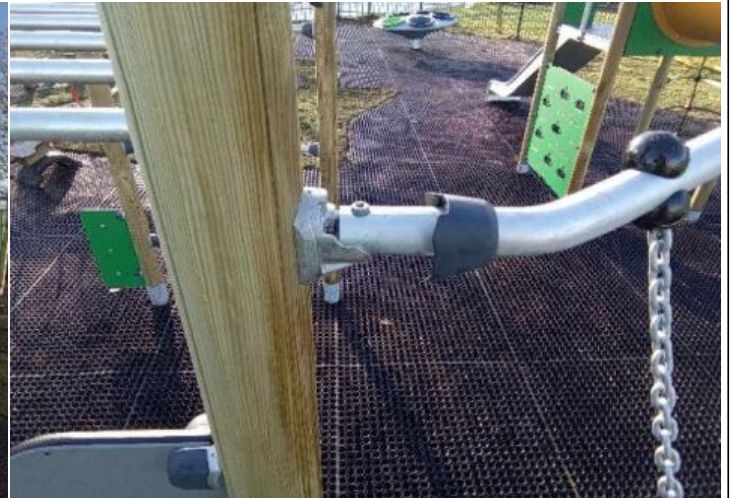
i 6 - Low Risk (Finding 5)

Finding: A connection cover is unsecured on the bridge

Action: Secure
