## Annual Inspection

Mid Suffolk District Council

Ringshall Village Hall

Inspection Ref: 2297566

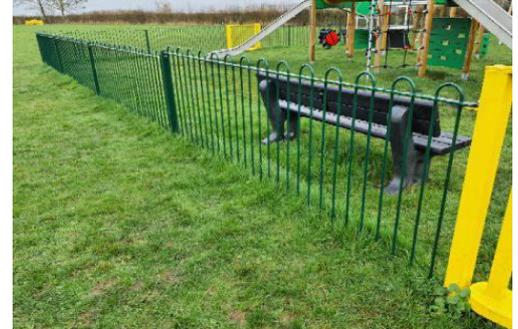
**Item:** Fence - Bow Top  
**Manufacturer:** I.A.E. Fencing  
**Surface Type:** Grass  
**Item Quantity:** 1  
**Equipment Compliance:** N/A  
**Surface Area Compliance:** N/A

Cable ties have been used on the item and there are sharp projecting ends - Remove if not required or replace with a more appropriate alternative fixing method if used as a fixing

Shear nuts have not been fully tightened and are still present on fixings - Tighten heads on nuts to shear off and secure

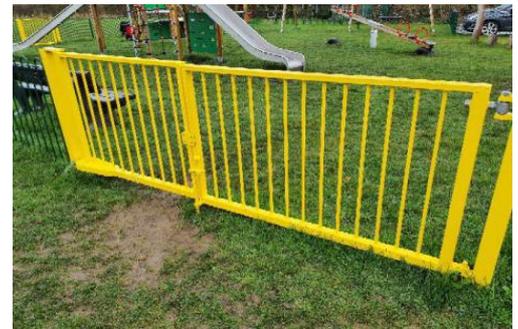
**Item:** Gate - Combination  
**Manufacturer:** I.A.E. Fencing  
**Surface Type:** Grass  
**Item Quantity:** 1  
**Equipment Compliance:** N/A  
**Surface Area Compliance:** N/A

There is no padlock on the maintenance gate - Provide a padlock to secure the gate

The area around the item has eroded and may become slippery - Reinststate eroded area

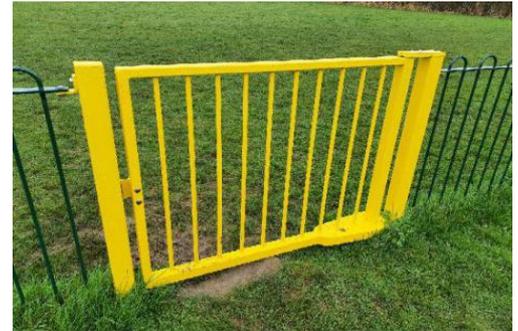
**Item:** Gate - Self Closing  
**Manufacturer:** I.A.E. Fencing  
**Surface Type:** Grass  
**Item Quantity:** 1  
**Equipment Compliance:** N/A  
**Surface Area Compliance:** N/A

The area around the item has eroded and may become slippery - Reinstate eroded area

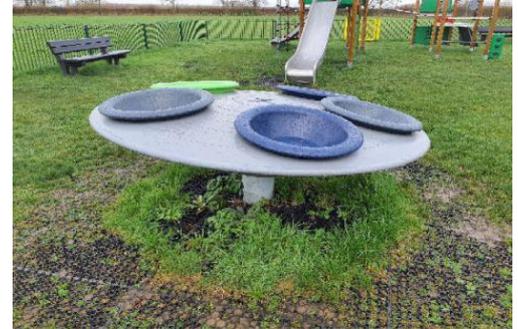
**Item:** Roundabout  
**Manufacturer:** Kompan Ltd  
**Surface Type:** Grass Matrix Tiles  
**Item Quantity:** 1  
**Equipment Compliance:** Yes  
**Surface Area Compliance:** Yes

There is weed / vegetation growth on, between, or around the edges of the surfacing - Remove weed / vegetation growth

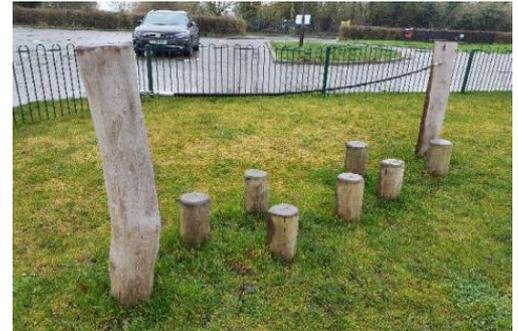
**Item:** Stepping Posts Timber  
**Manufacturer:** Kompan Ltd  
**Surface Type:** Grass Matrix Tiles  
**Item Quantity:** 1  
**Equipment Compliance:** Yes  
**Surface Area Compliance:** Yes

There are splits running through the timber that cross through or near fixing points and may cause instability in the future - Monitor stability of fixings

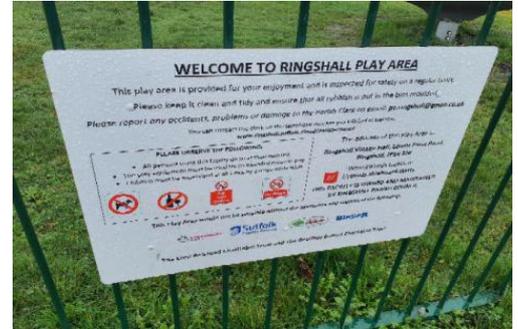
**Item:** Sign  
**Manufacturer:** Not Identified  
**Surface Type:** N/A  
**Item Quantity:** 1  
**Equipment Compliance:** N/A  
**Surface Area Compliance:** N/A

There are projecting bolt thread(s) present - Remove excess thread length and deburr or provide cap

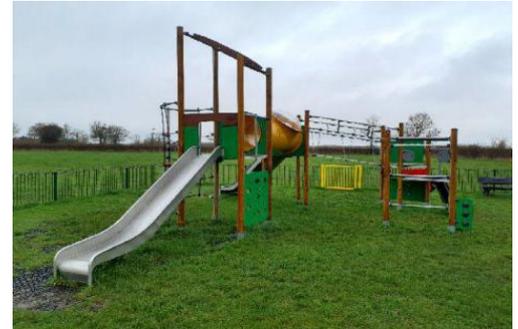
**Item:** Multi Play (Junior)  
**Manufacturer:** Kompan Ltd  
**Surface Type:** Grass Matrix Tiles  
**Item Quantity:** 1  
**Equipment Compliance:** Yes  
**Surface Area Compliance:** Yes

The slide is predominately south facing and will catch the majority of the sun's heat during the day. Slide surfaces can become very warm during periods of sustained sunny weather - Monitor - No remedial work recommended

There is/are bolt cap covers missing or damaged on the item - Replace missing or damaged bolt cap covers

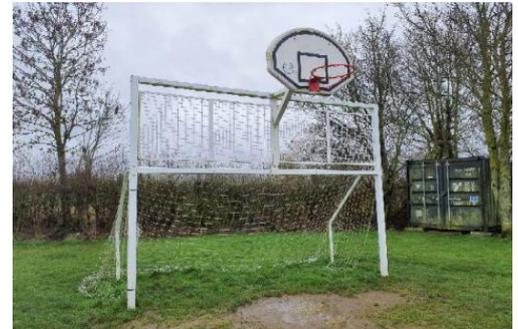
**Item:** Goalmouth and Basketball Post  
**Manufacturer:** Not Identified  
**Surface Type:** Grass  
**Item Quantity:** 1  
**Equipment Compliance:** No  
**Surface Area Compliance:** N/A

The surface has eroded in some areas and may be slippery in wet conditions - Reinstate the surface

There is some damage to the nets - Repair or replace as required

Cable ties have been used on the item and there are sharp projecting ends - Remove if not required or replace with a more appropriate alternative fixing method if used as a fixing

The item fails to meet the requirements of BS EN 15312 4.4.2.1 head and neck entrapment in the frame - Monitor - No remedial work recommended

The weld(s) on this item have failed - Repair item

There are projecting bolt thread(s) present - Remove excess thread length and deburr or provide cap

The item is slightly loose in its foundations - Monitor for any further deterioration and repair as required

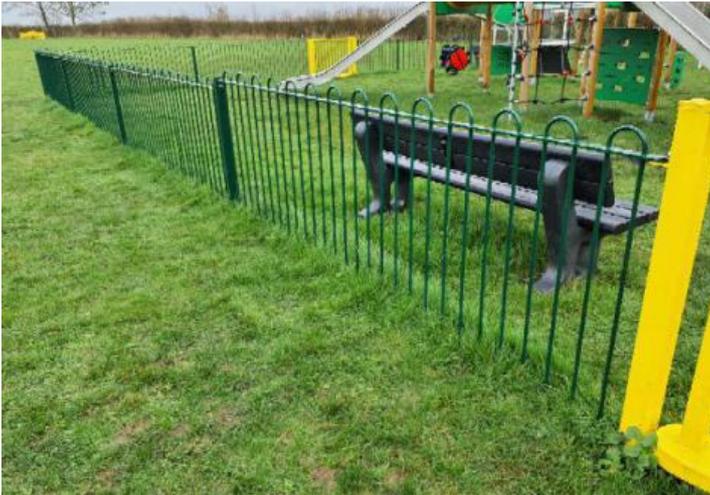
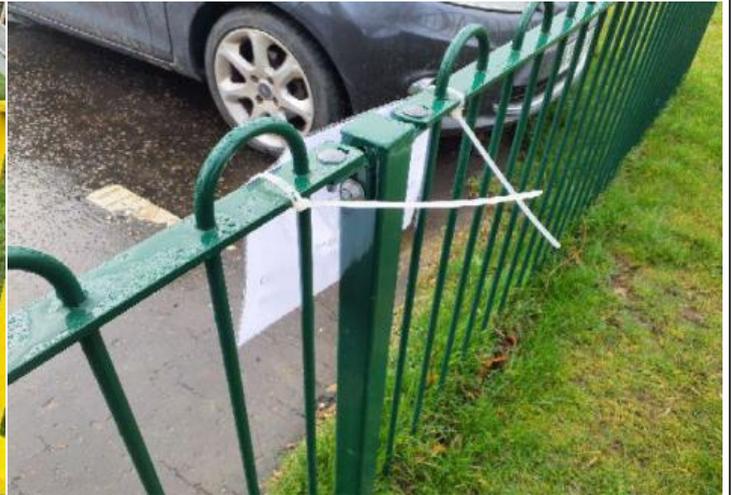
### 6 - Low Risk (Finding 1)

**Item:** Fences - Fence - Bow Top  
**Manufacturer:** I.A.E. Fencing

**Finding:** Cable ties have been used on the item and there are sharp projecting ends

**Action:** Remove if not required or replace with a more appropriate alternative fixing method if used as a fixing

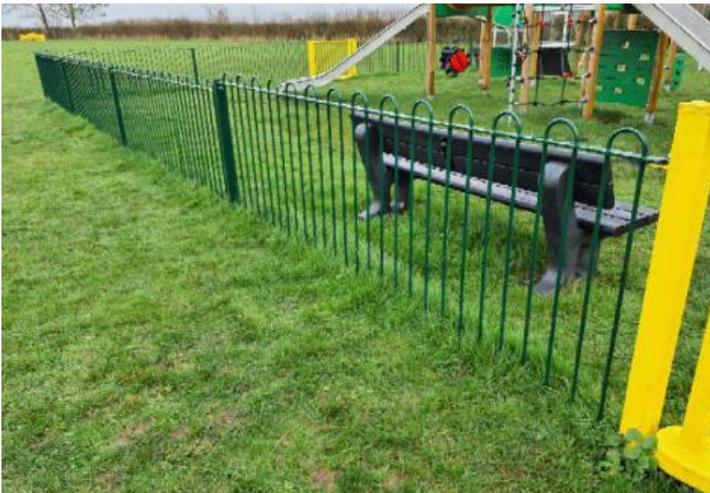
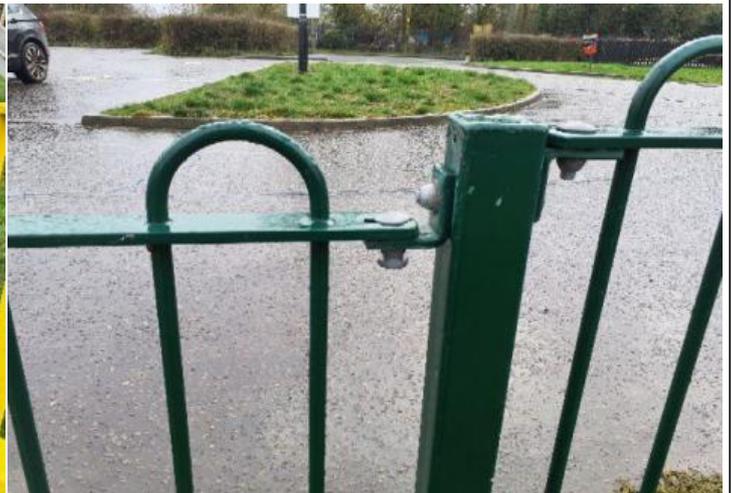
### 4 - Very Low Risk (Finding 2)

**Item:** Fences - Fence - Bow Top  
**Manufacturer:** I.A.E. Fencing

**Finding:** Shear nuts have not been fully tightened and are still present on fixings

**Action:** Tighten heads on nuts to shear off and secure

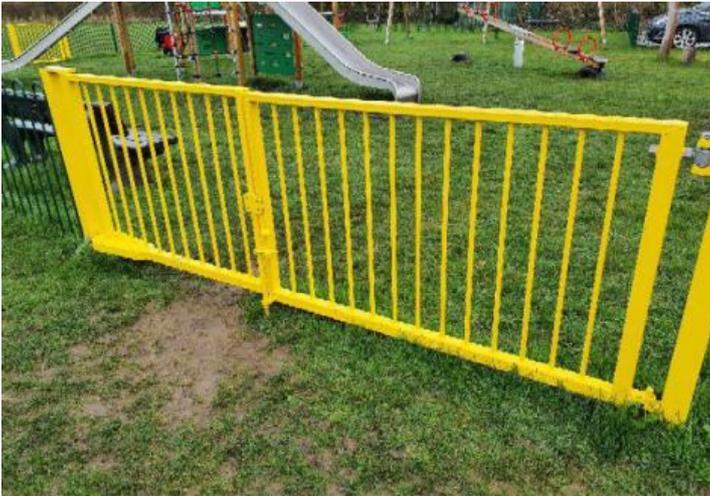
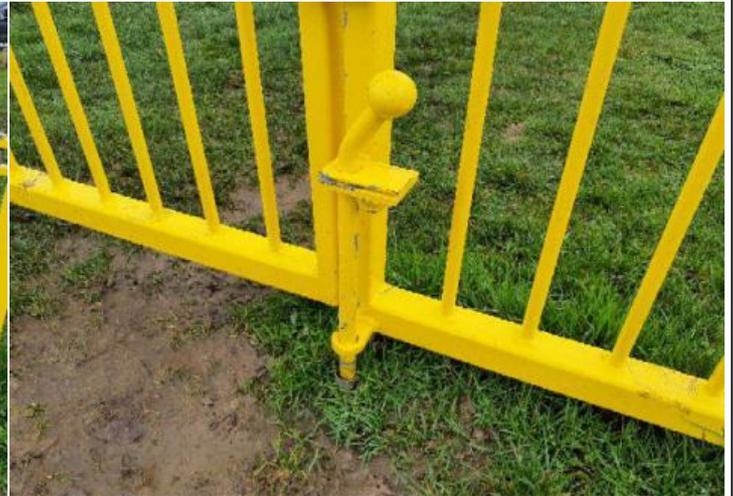
**i** 6 - Low Risk (Finding 1)

**Item:** Gates - Gate - Combination  
**Manufacturer:** I.A.E. Fencing

**Finding:** There is no padlock on the maintenance gate

**Action:** Provide a padlock to secure the gate

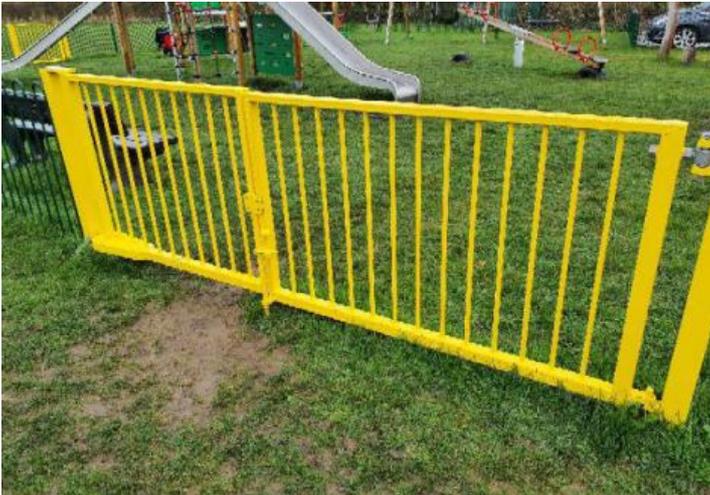
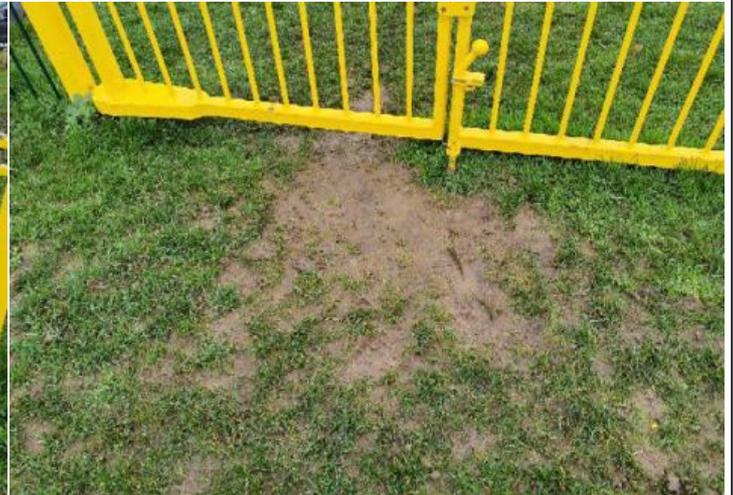
**i** 8 - Low Risk (Finding 2)

**Item:** Gates - Gate - Combination  
**Manufacturer:** I.A.E. Fencing

**Finding:** The area around the item has eroded and may become slippery

**Action:** Reinstate eroded area

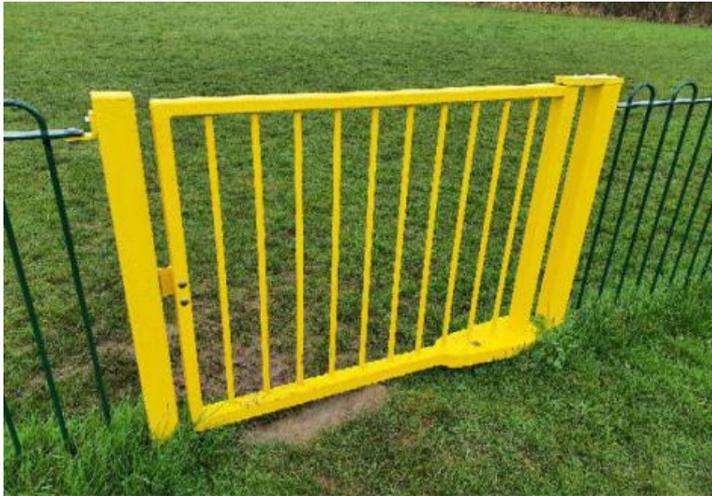
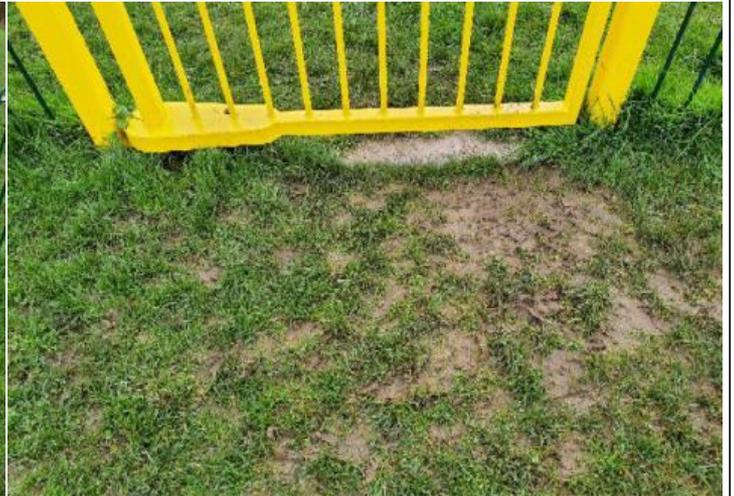
**i** 6 - Low Risk (Finding 1)

**Item:** Gates - Gate - Self Closing  
**Manufacturer:** I.A.E. Fencing

**Finding:** The area around the item has eroded and may become slippery

**Action:** Reinststate eroded area

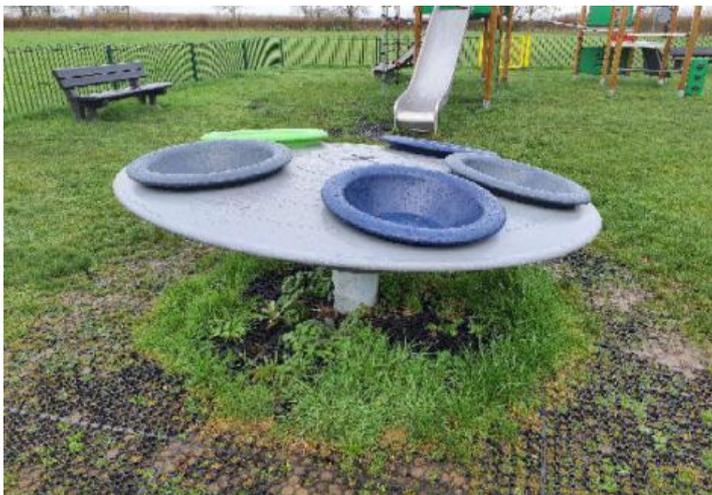
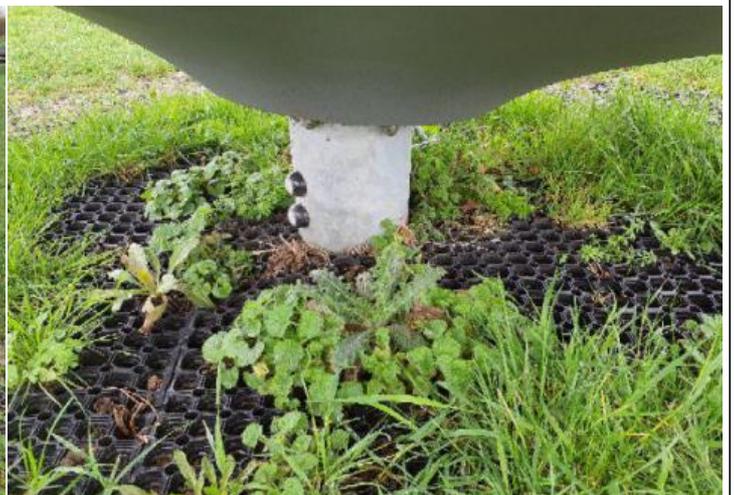
**i** 6 - Low Risk (Finding 1)

**Item:** Rotor Play - Roundabout  
**Manufacturer:** Kompan Ltd

**Finding:** There is weed / vegetation growth on, between, or around the edges of the surfacing

**Action:** Remove weed / vegetation growth

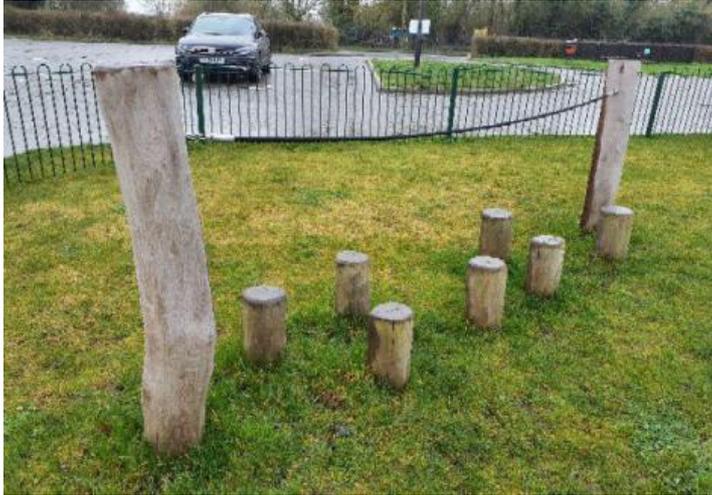
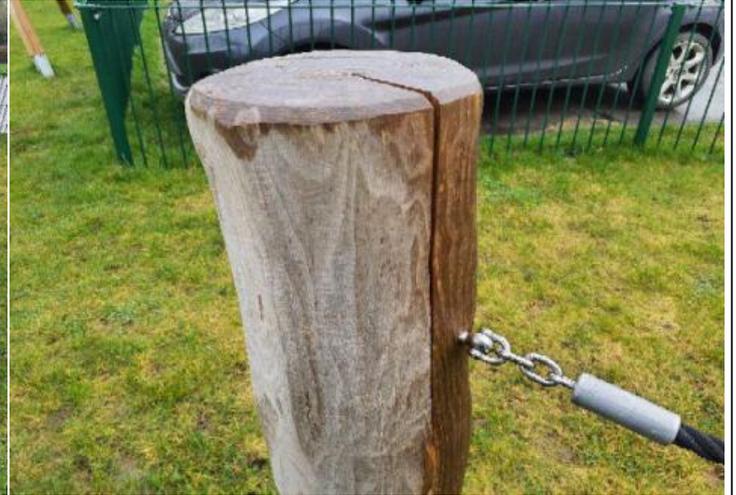
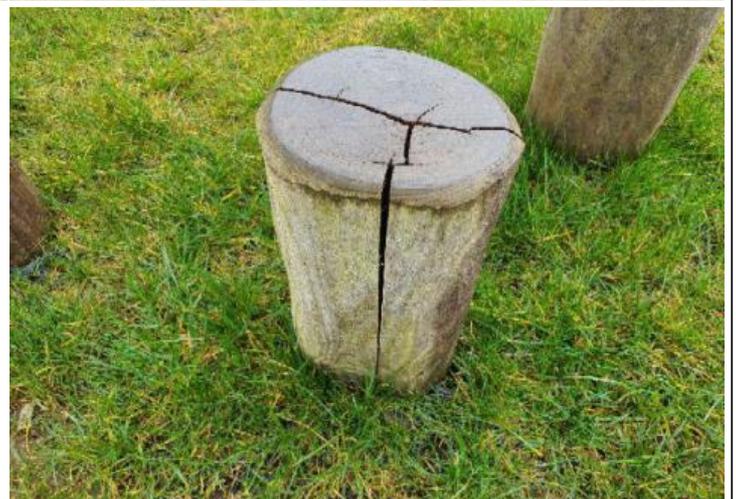
**i** 8 - Low Risk (Finding 1)

**Item:** Activity Equipment - Stepping Posts  
Timber  
**Manufacturer:** Kompan Ltd

**Finding:** There are splits running through the timber that cross through or near fixing points and may cause instability in the future

**Action:** Monitor stability of fixings

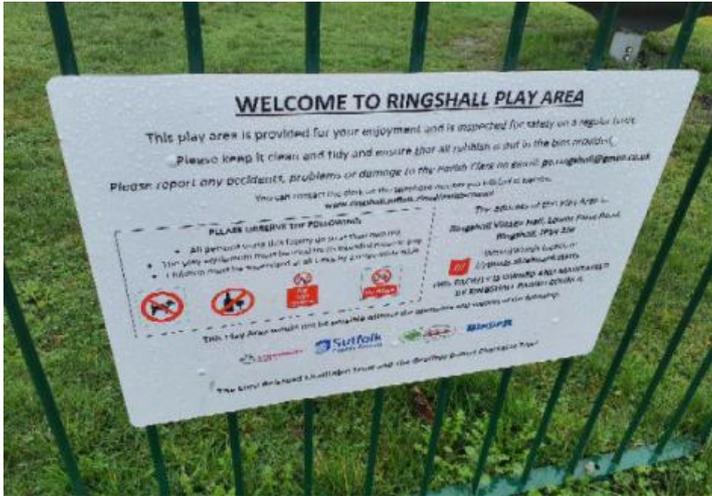
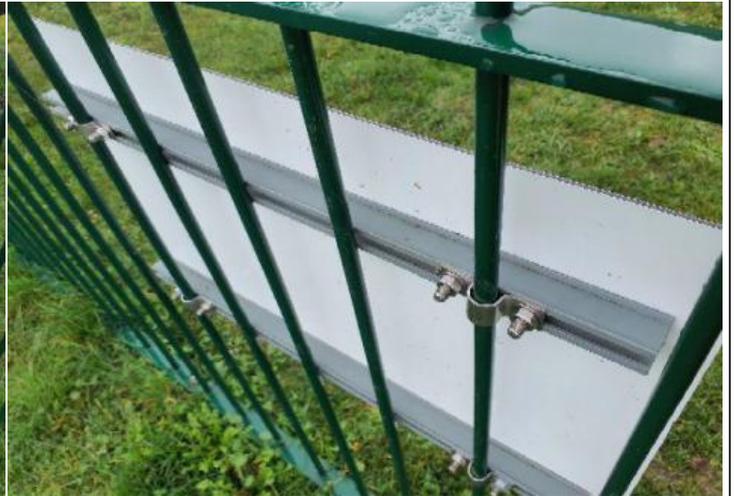
**i** 8 - Low Risk (Finding 1)

**Item:** Ancillary Items - Sign  
**Manufacturer:** Not Identified

**Finding:** There are projecting bolt thread(s) present

**Action:** Remove excess thread length and deburr or provide cap

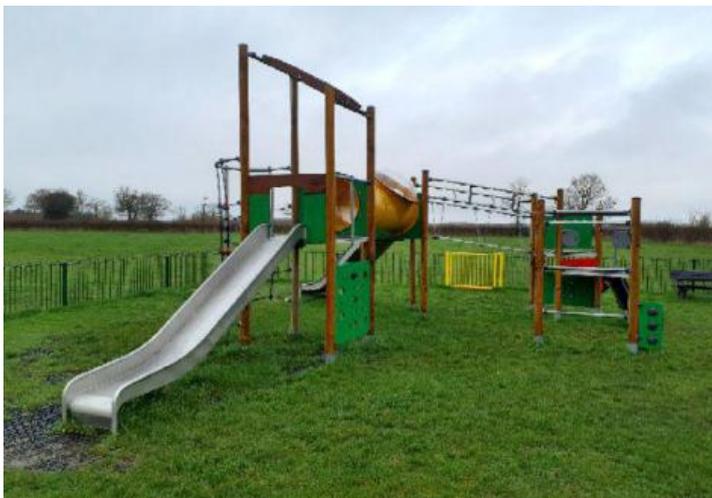
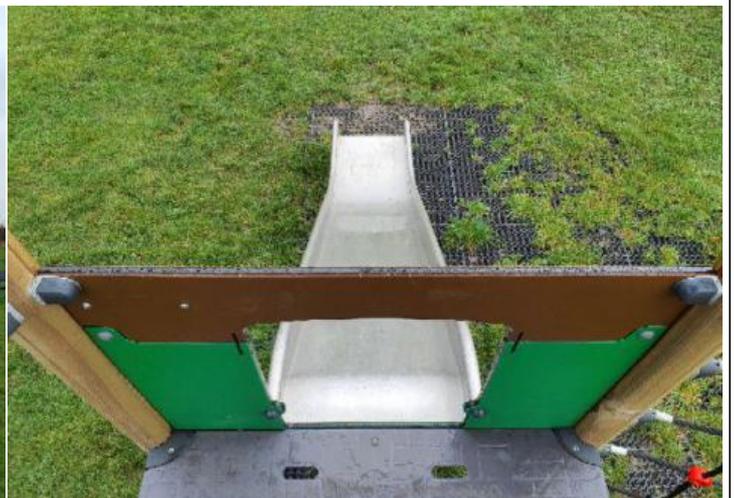
**i** 6 - Low Risk (Finding 1)

**Item:** Activity Equipment - Multi Play (Junior)  
**Manufacturer:** Kompan Ltd

**Finding:** The slide is predominately south facing and will catch the majority of the sun's heat during the day. Slide surfaces can become very warm during periods of sustained sunny weather

**Action:** Monitor - No remedial work recommended

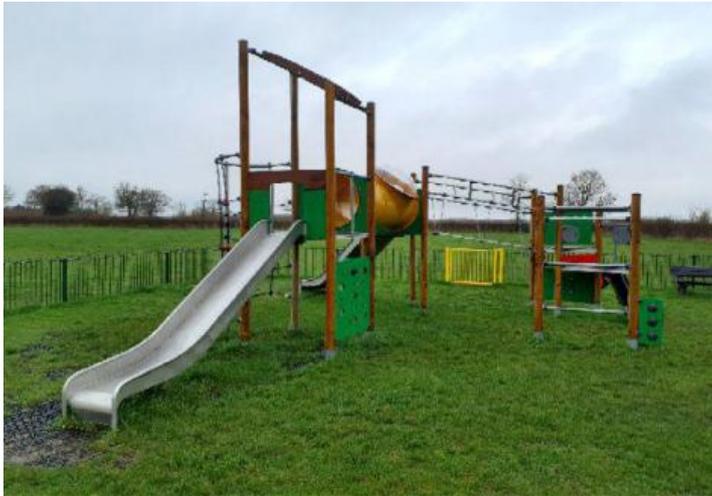
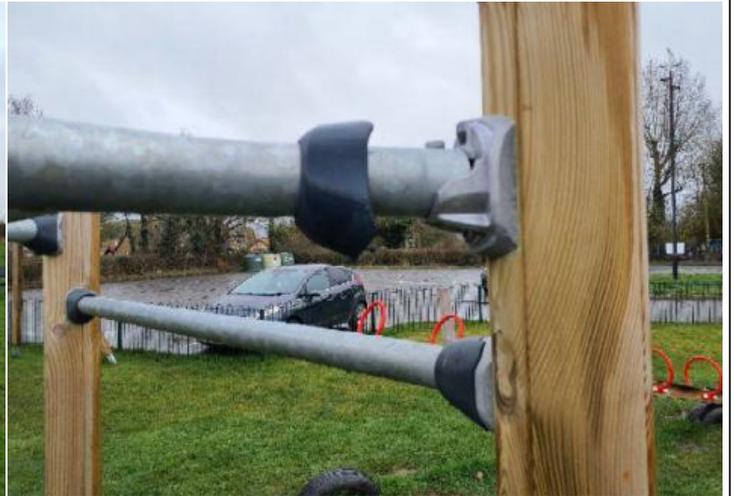
**i** 6 - Low Risk (Finding 2)

**Item:** Activity Equipment - Multi Play (Junior)  
**Manufacturer:** Kompan Ltd

**Finding:** There is/are bolt cap covers missing or damaged on the item

**Action:** Replace missing or damaged bolt cap covers

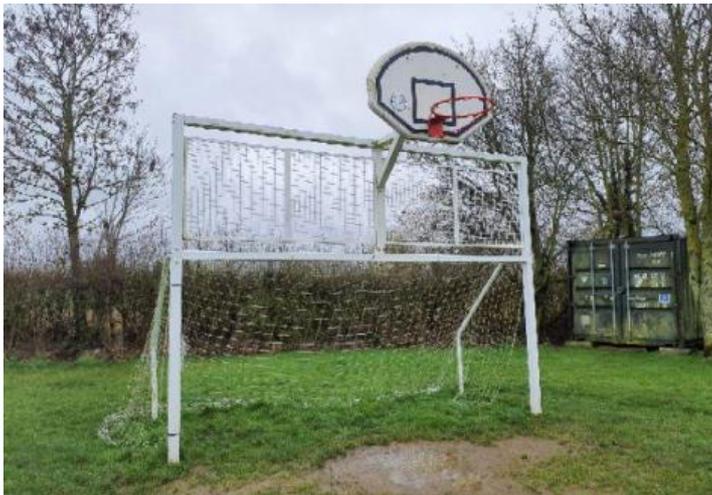
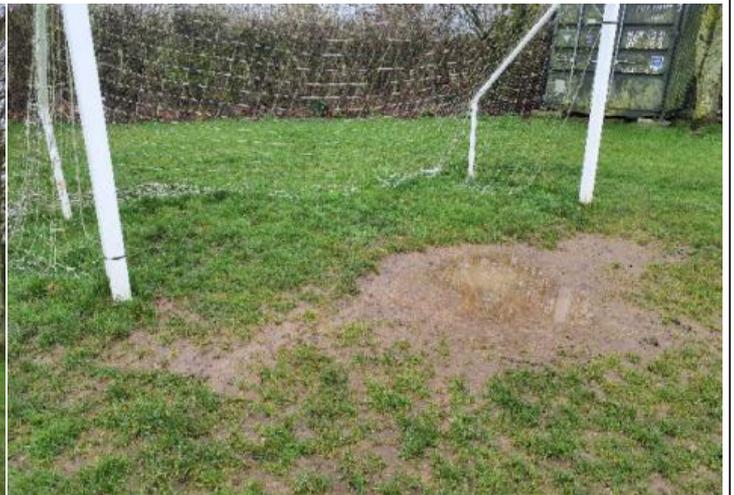
**i** 6 - Low Risk (Finding 1)

**Item:** Multi Use Games Area - Goalmouth and Basketball Post  
**Manufacturer:** Not Identified

**Finding:** The surface has eroded in some areas and may be slippery in wet conditions

**Action:** Reinstate the surface

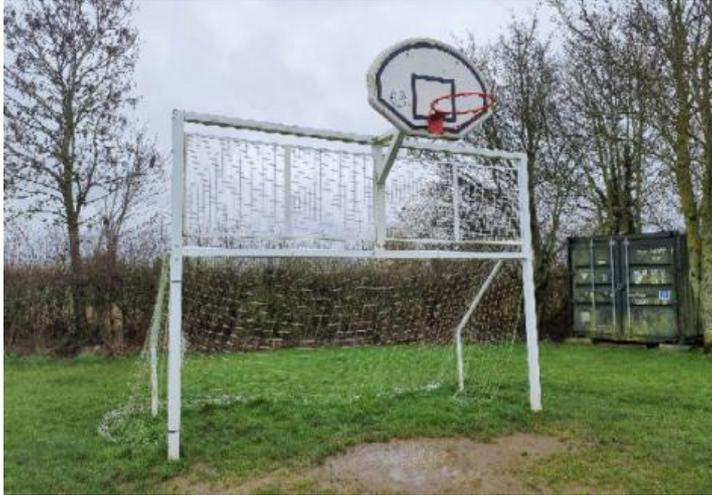
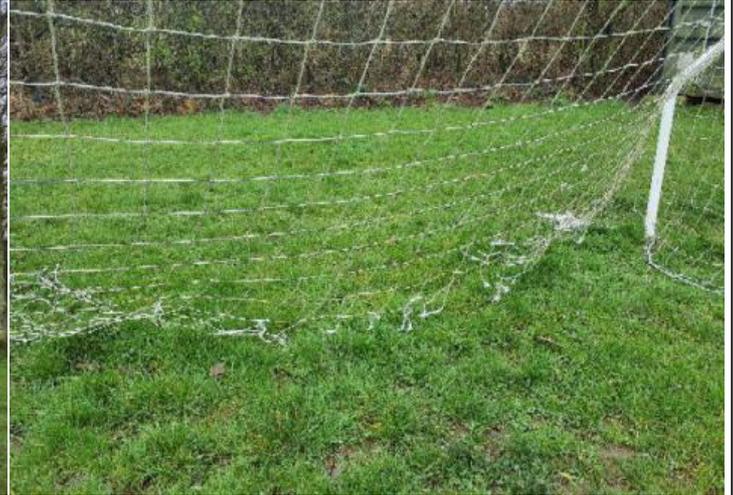
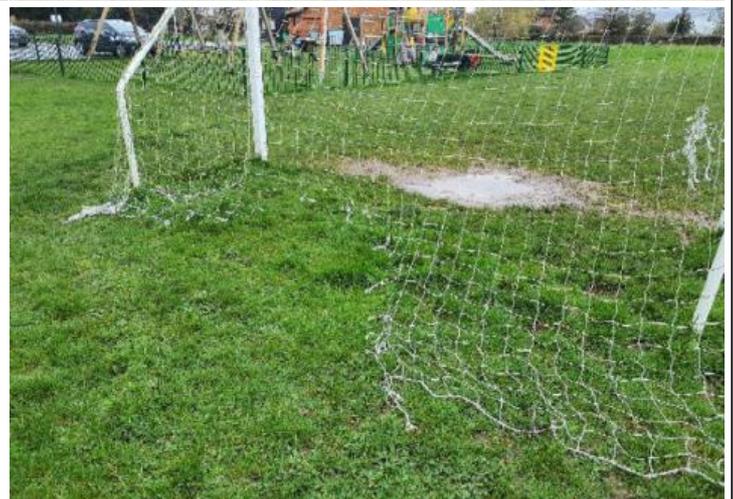
**i** 6 - Low Risk (Finding 2)

**Item:** Multi Use Games Area - Goalmouth and Basketball Post  
**Manufacturer:** Not Identified

**Finding:** There is some damage to the nets

**Action:** Repair or replace as required

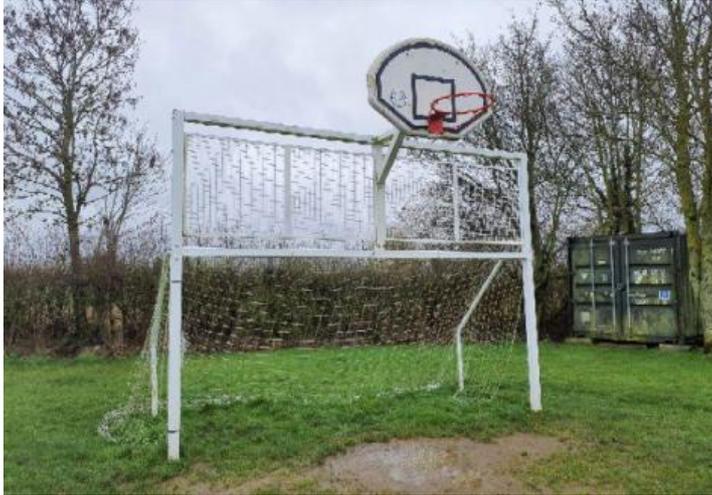
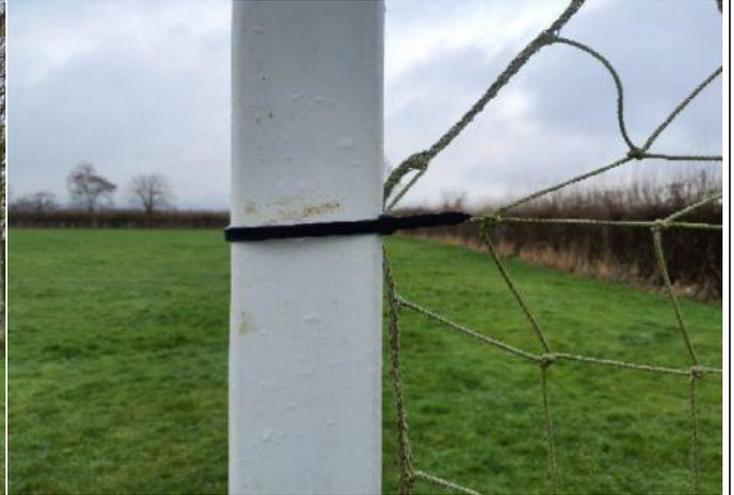
**i** 6 - Low Risk (Finding 3)

**Item:** Multi Use Games Area - Goalmouth and Basketball Post  
**Manufacturer:** Not Identified

**Finding:** Cable ties have been used on the item and there are sharp projecting ends

**Action:** Remove if not required or replace with a more appropriate alternative fixing method if used as a fixing

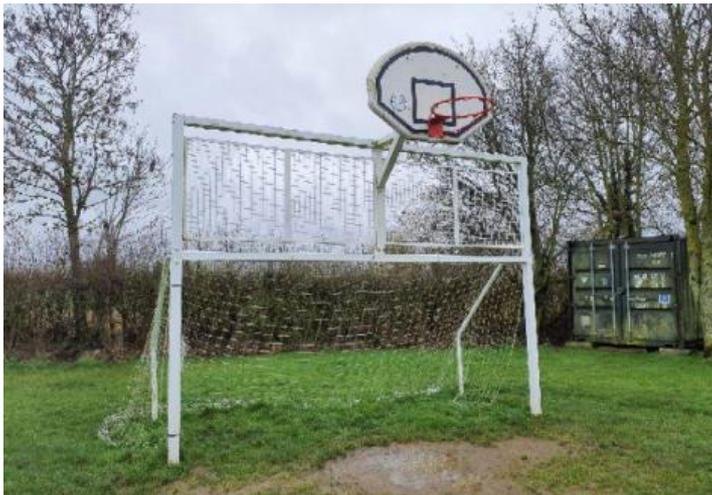
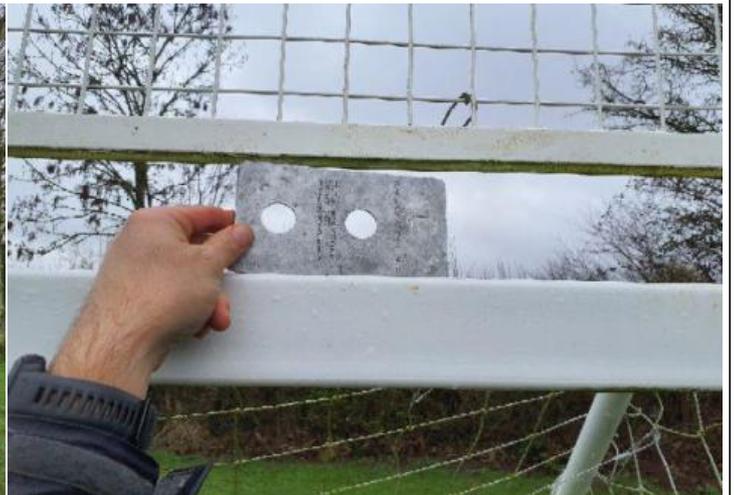
**i** 5 - Very Low Risk (Finding 4)

**Item:** Multi Use Games Area - Goalmouth and Basketball Post  
**Manufacturer:** Not Identified

**Finding:** The item fails to meet the requirements of BS EN 15312 4.4.2.1 head and neck entrapment in the frame

**Action:** Monitor - No remedial work recommended

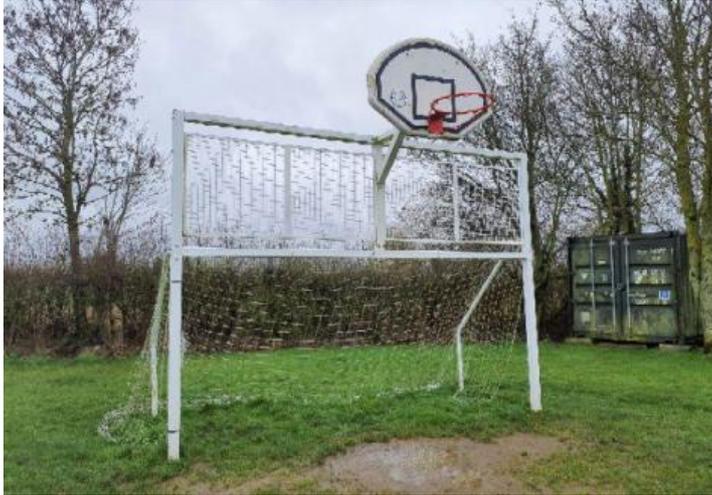
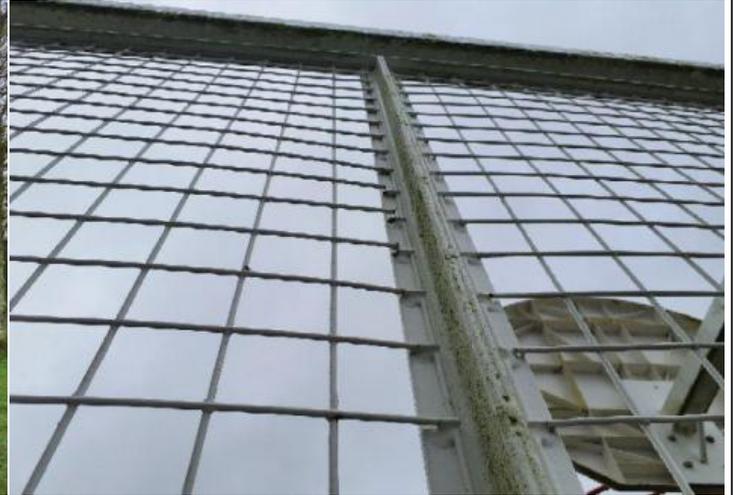
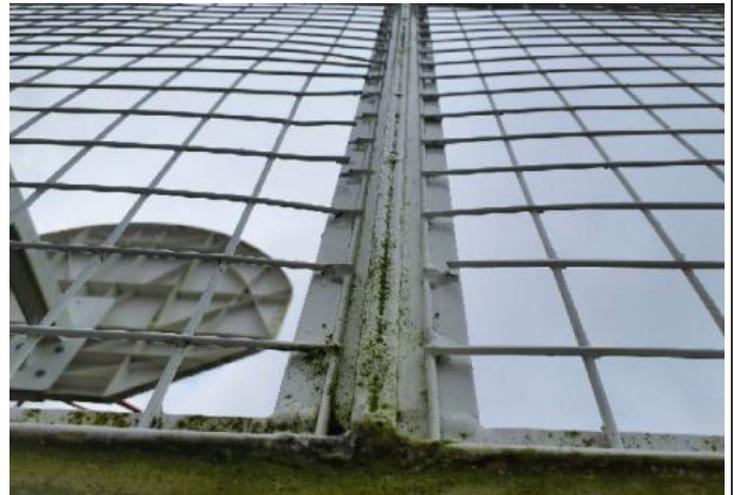
**i** 8 - Low Risk (Finding 5)

**Item:** Multi Use Games Area - Goalmouth and Basketball Post  
**Manufacturer:** Not Identified

**Finding:** The weld(s) on this item have failed

**Action:** Repair item

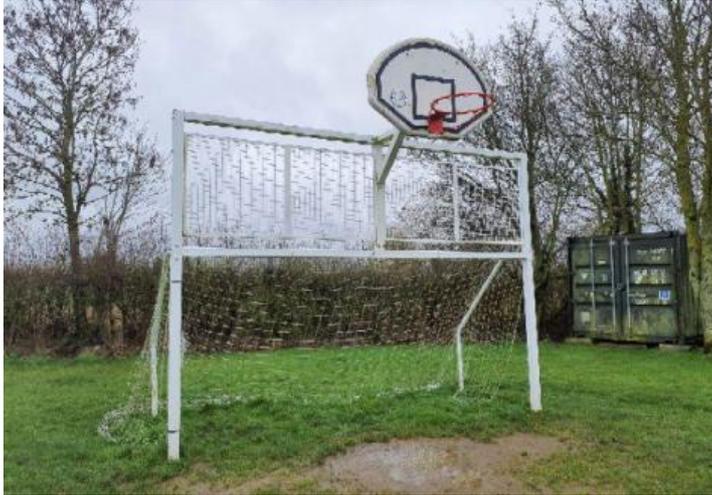
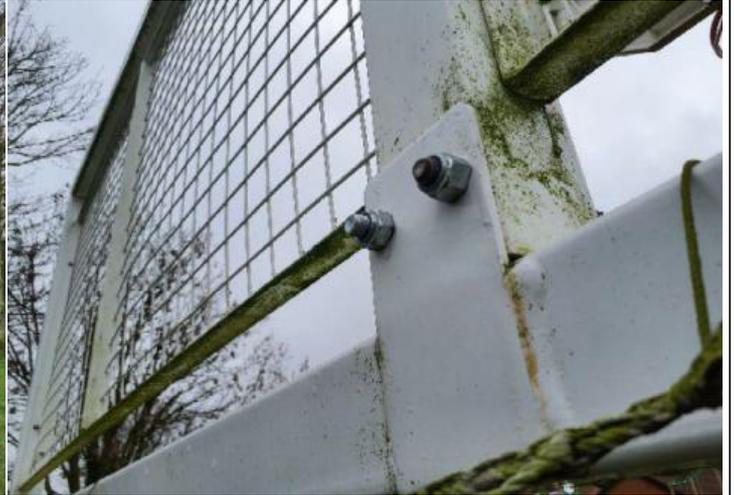
**i** 8 - Low Risk (Finding 6)

**Item:** Multi Use Games Area - Goalmouth and Basketball Post  
**Manufacturer:** Not Identified

**Finding:** There are projecting bolt thread(s) present

**Action:** Remove excess thread length and deburr or provide cap

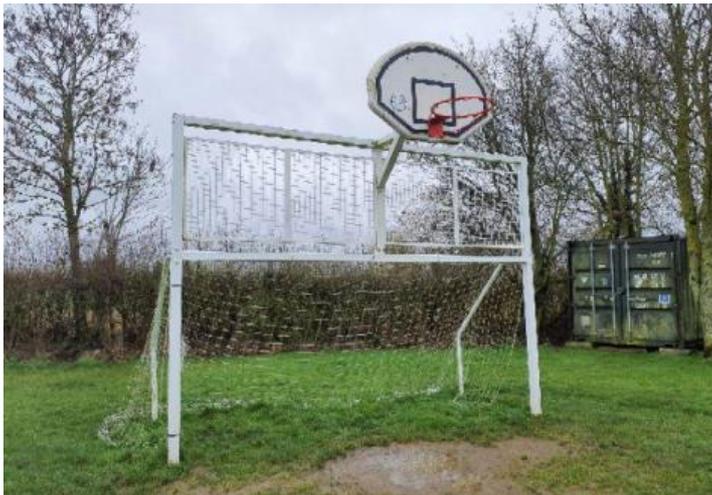
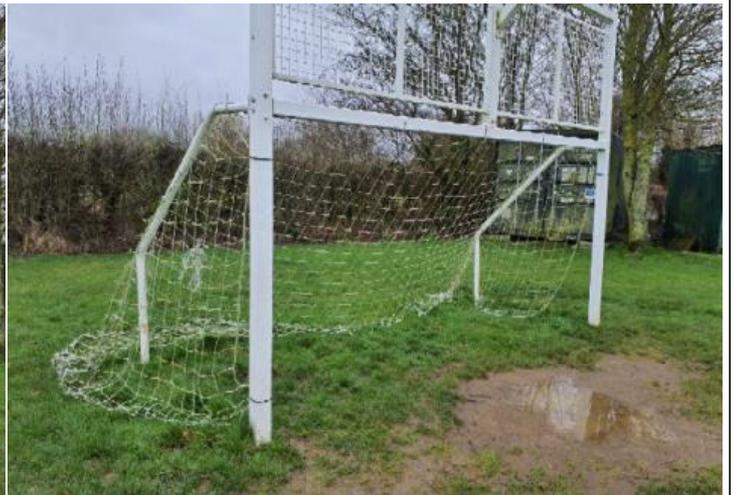
**i** 6 - Low Risk (Finding 7)

**Item:** Multi Use Games Area - Goalmouth and Basketball Post  
**Manufacturer:** Not Identified

**Finding:** The item is slightly loose in its foundations

**Action:** Monitor for any further deterioration and repair as required
