Annual Inspection

Mid Suffolk District Council

Ringshall Village Hall

Inspected: 2-March-2026 - 08:23 by James Law (RPII Annual Inspector)

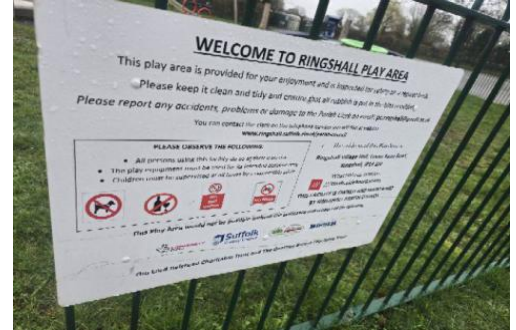
Item: Sign
Manufacturer: Not Identified
Surface Type: N/A
Item Quantity: 1
Equipment Compliance: N/A
Surface Area Compliance: N/A

There are projecting bolt thread(s) present - Remove excess thread length and deburr or provide cap

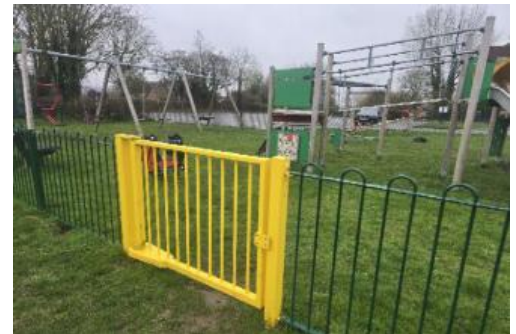
Item: Gate - Self Closing
Manufacturer: I.A.E. Fencing
Surface Type: Grass
Item Quantity: 1
Equipment Compliance: N/A
Surface Area Compliance: N/A

This item is satisfactory - no work required -

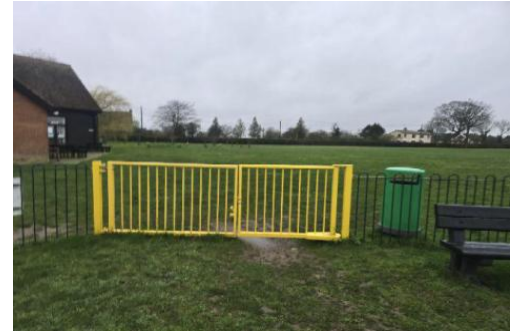
Item: Gate - Combination
Manufacturer: I.A.E. Fencing
Surface Type: Grass
Item Quantity: 1
Equipment Compliance: N/A
Surface Area Compliance: N/A

The area around the item has eroded and may become slippery - Reinstate eroded area

The gate is closing too quickly (less than 4 seconds) - Take corrective action to ensure that the gate closes in 4-8 seconds from 90 degrees

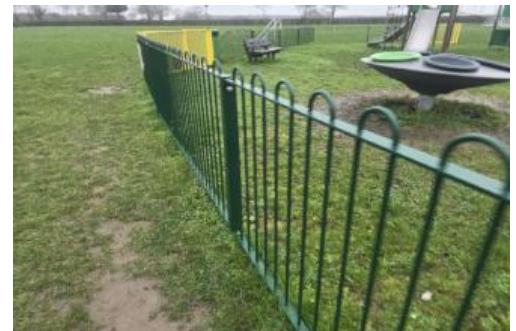
Item: Fence - Bow Top
Manufacturer: I.A.E. Fencing
Surface Type: Grass
Item Quantity: 1
Equipment Compliance: N/A
Surface Area Compliance: N/A

This item is satisfactory - no work required -

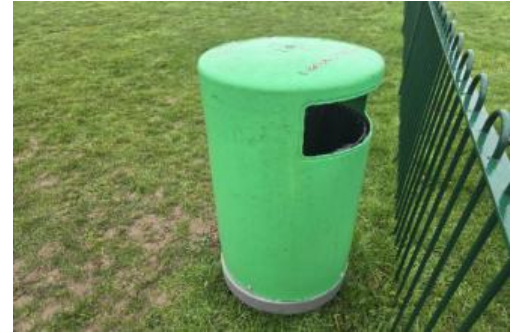
Item: Litter Bin
Manufacturer: Glasdon
Surface Type: Grass
Item Quantity: 1
Equipment Compliance: N/A
Surface Area Compliance: N/A

This item is satisfactory - no work required -

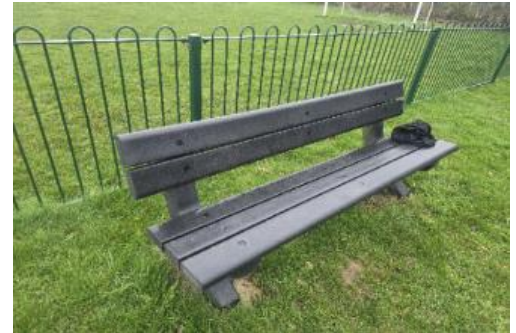
Item: Bench
Manufacturer: Glasdon
Surface Type: Grass
Item Quantity: 2
Equipment Compliance: N/A
Surface Area Compliance: N/A

This item is satisfactory - no work required -

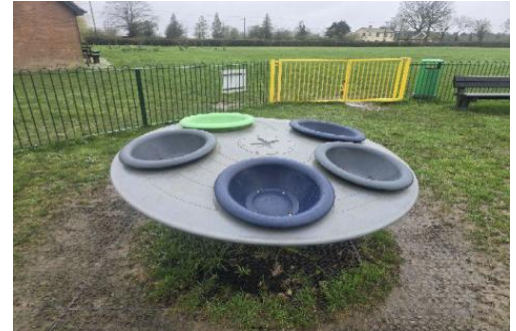
Item: Roundabout
Manufacturer: Kompan Ltd
Surface Type: Grass Matrix Tiles
Item Quantity: 1
Equipment Compliance: Yes
Surface Area Compliance: Yes
Life Expectancy: 5 -10 Years
Total Findings: 2

The grass mats are silted up, the soil is compacted and the area will become very slippery when the soil is wet. - Reinstate as required

There is weed / vegetation growth within the surface - Remove weed / vegetation growth

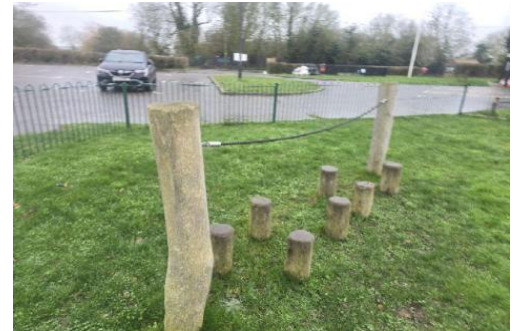
Item: Stepping Posts Timber
Manufacturer: Kompan Ltd
Surface Type: Grass Matrix Tiles
Item Quantity: 1
Equipment Compliance: Yes
Surface Area Compliance: Yes
Life Expectancy: 5 -10 Years
Total Findings: 1

There are splits running through the timber - Monitor and ensure any rough or splintering edges are sanded down

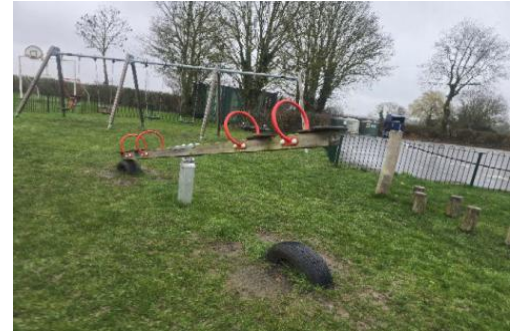
Item: See Saw
Manufacturer: Kompan Ltd
Surface Type: Grass Matrix Tiles
Item Quantity: 1
Equipment Compliance: Yes
Surface Area Compliance: Yes
Life Expectancy: 5 -10 Years
Total Findings: 1

There is algae or moss on the surface of the equipment - Clean and treat appropriately

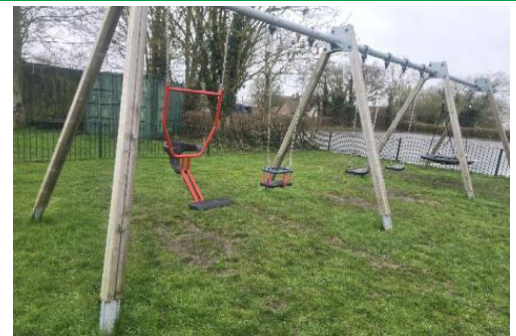
Item: 3 Bay Swing
Manufacturer: Kompan Ltd
Surface Type: Grass Matrix Tiles
Item Quantity: 1
Equipment Compliance: Yes
Surface Area Compliance: Yes
Life Expectancy: >10 Years
Total Findings: 2

The suspension lugs are showing signs of wear - Monitor for any further deterioration and repair as required

The secondary safety shackles are worn in excess of 40% and require renewing - Replace worn shackles

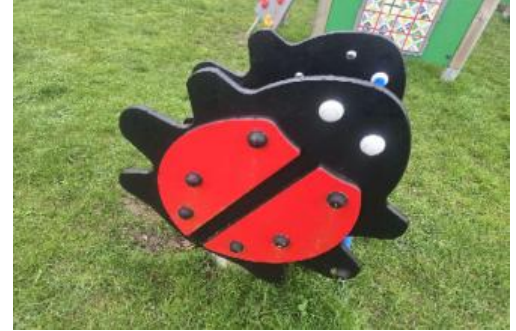
Item: Spring Ladybird
Manufacturer: Kompan Ltd
Surface Type: Grass Matrix Tiles
Item Quantity: 1
Equipment Compliance: Yes
Surface Area Compliance: Yes
Life Expectancy: 5 -10 Years
Total Findings: 1

This item is satisfactory - no work required -

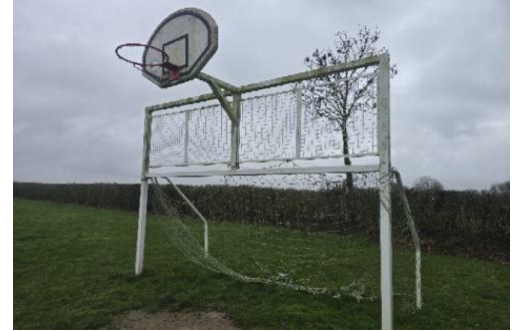
Item: Goalmouth and Basketball Post
Manufacturer: Not Identified
Surface Type: Grass
Item Quantity: 1
Equipment Compliance: No
Surface Area Compliance: N/A
Life Expectancy: 5 -10 Years
Total Findings: 7

The net is damaged and requires removal / replacement - Replace

The area around the item has eroded and may become slippery - Reinststate eroded area

The item fails to meet the requirements of BS EN 15312 4.4.2.1 head and neck entrapment in the framework - Monitor - No action given the risk assessment

There are projecting bolt thread(s) present - Remove excess thread length and deburr or provide cap

The item is slightly loose in its foundations - Monitor for any further deterioration and repair as required

The weld(s) on this item have failed - Repair item

A clearly visible facility sign should be provided in a prominent position with the wording as detailed BS EN 15312- the equipment is not intended for children less than 3 years old- the warning - Do not climb on the framework or nets- the warning - Do not hang on the ring (if provided)- the warning - Do not wear rings or other jewellery- name and telephone number of the administrator- number to call in case of accident - Provide signage to BS EN 15312

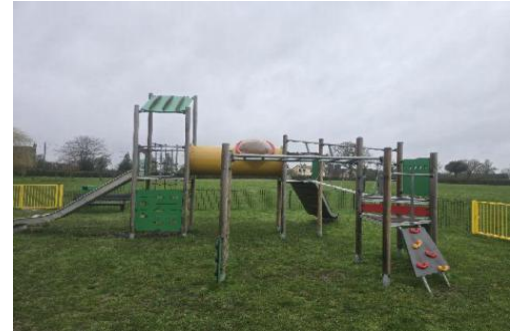
Item: Multi Play (Junior)
Manufacturer: Kompan Ltd
Surface Type: Grass Matrix Tiles
Item Quantity: 1
Equipment Compliance: Yes
Surface Area Compliance: Yes
Life Expectancy: >10 Years
Total Findings: 2

The slide is predominately south facing and will catch the majority of the sun's heat during the day. Slide surfaces can become very warm during periods of sustained sunny weather - Monitor - No action given the risk assessment

A number of fixing(s) have worked loose - Secure all loose fixings

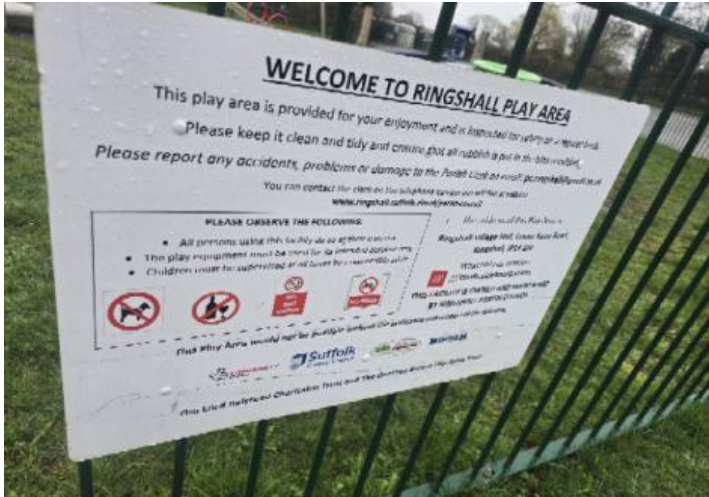
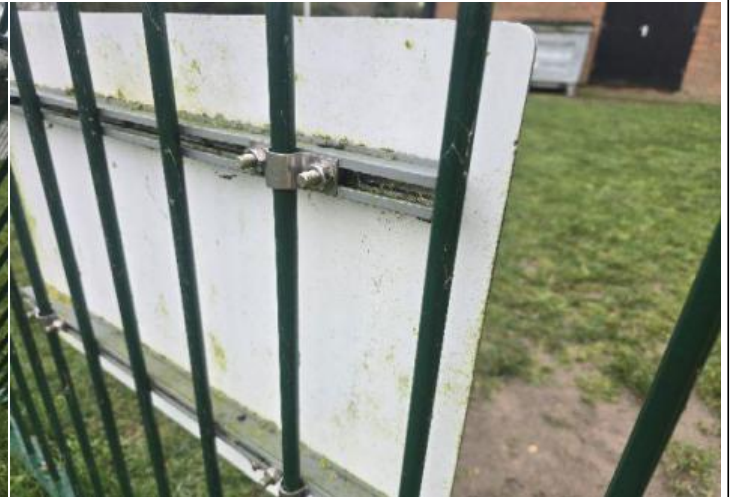
8 - Low Risk (Finding 1)

Item: Ancillary Items - Sign
Manufacturer: Not Identified

Finding: There are projecting bolt thread(s) present

Action: Remove excess thread length and deburr or provide cap

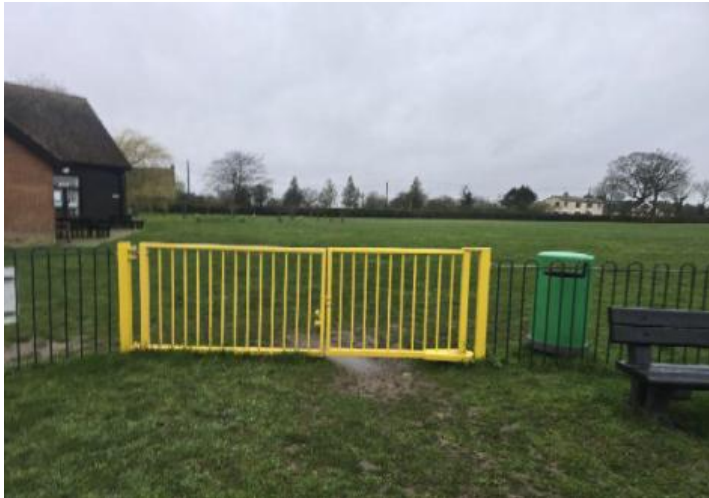
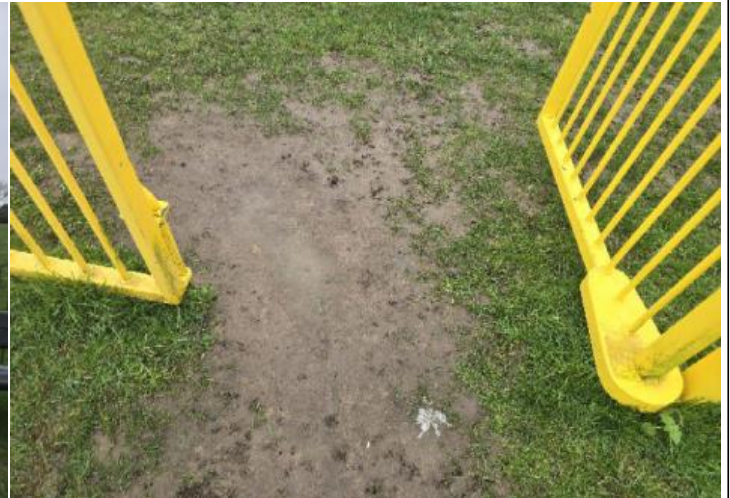
i 8 - Low Risk (Finding 1)

Item: Gates - Gate - Combination
Manufacturer: I.A.E. Fencing

Finding: The area around the item has eroded and may become slippery

Action: Reinstate eroded area

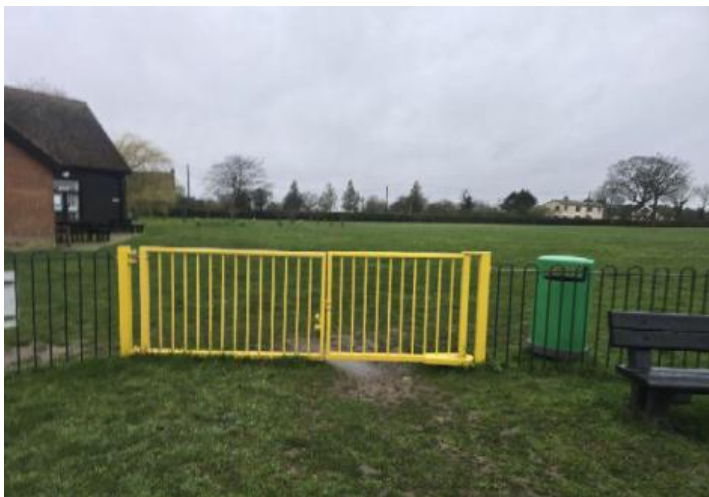
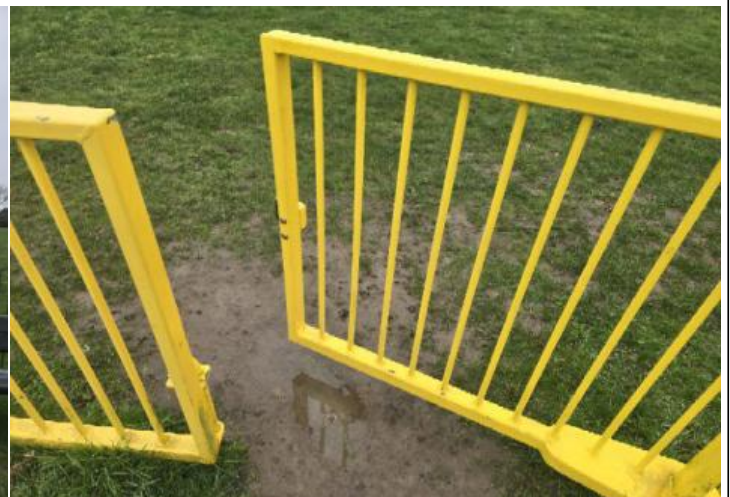
i 8 - Low Risk (Finding 2)

Item: Gates - Gate - Combination
Manufacturer: I.A.E. Fencing

Finding: The gate is closing too quickly (less than 4 seconds)

Action: Take corrective action to ensure that the gate closes in 4-8 seconds from 90 degrees

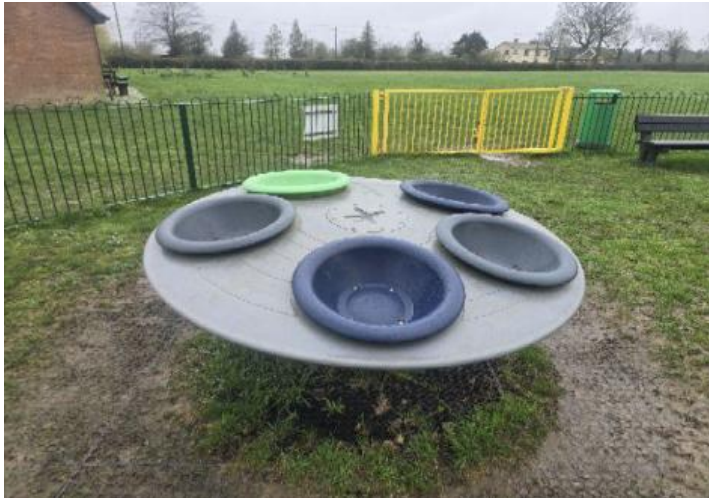
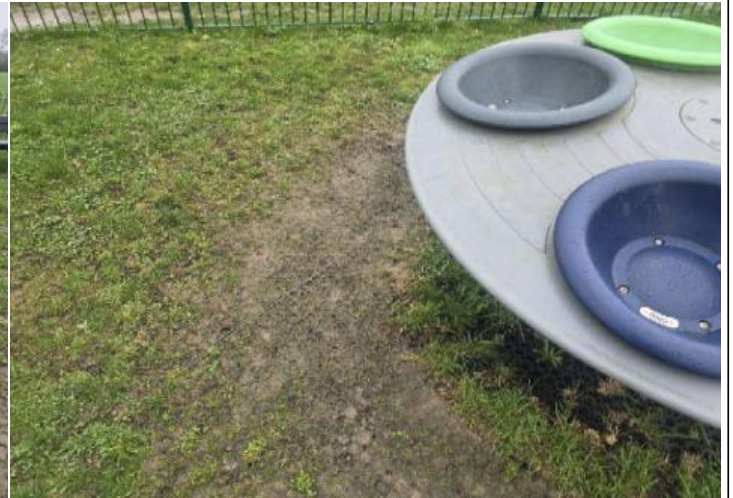
i 8 - Low Risk (Finding 1)

Item: Rotor Play - Roundabout
Manufacturer: Kompan Ltd

Finding: The grass mats are silted up, the soil is compacted and the area will become very slippery when the soil is wet. **Action:** Reinstate as required

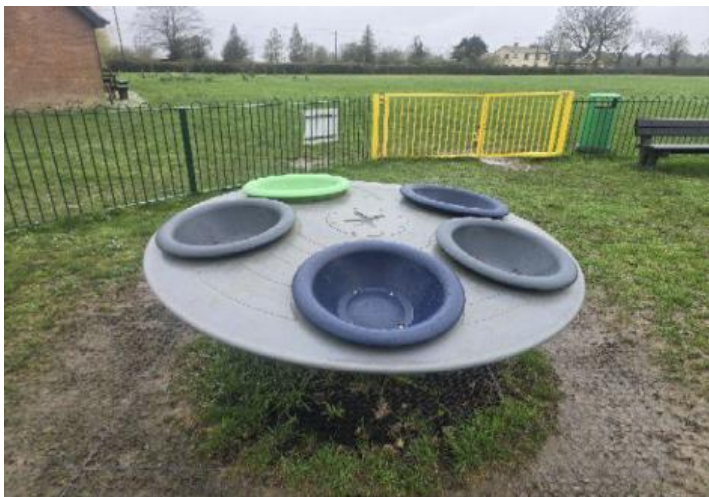
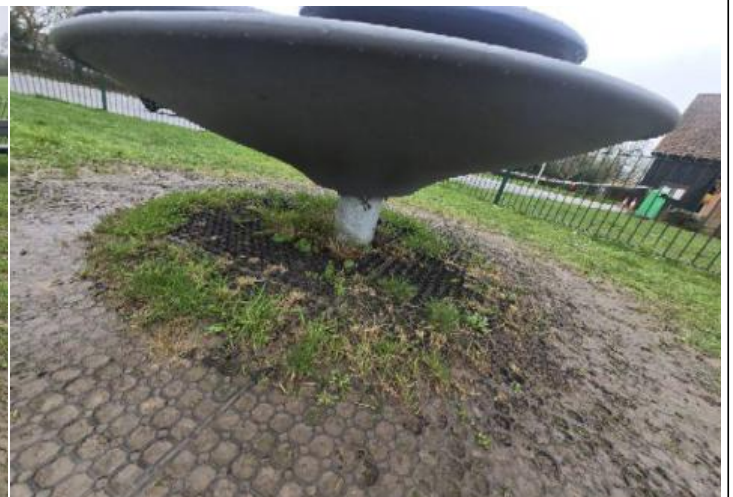
i 6 - Low Risk (Finding 2)

Item: Rotor Play - Roundabout
Manufacturer: Kompan Ltd

Finding: There is weed / vegetation growth within the surface **Action:** Remove weed / vegetation growth

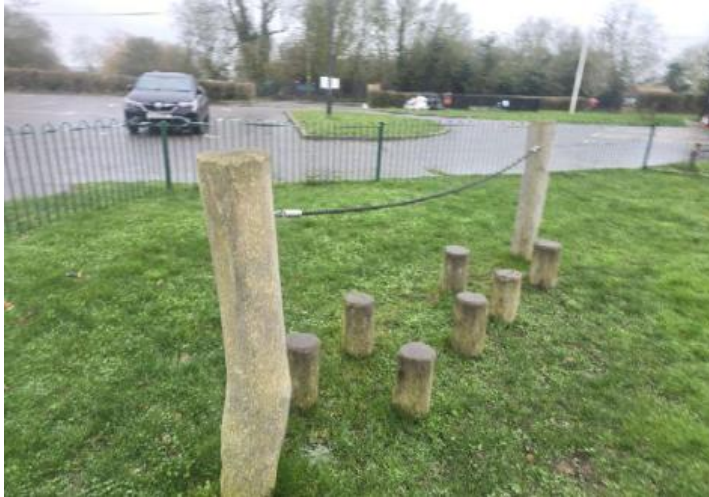
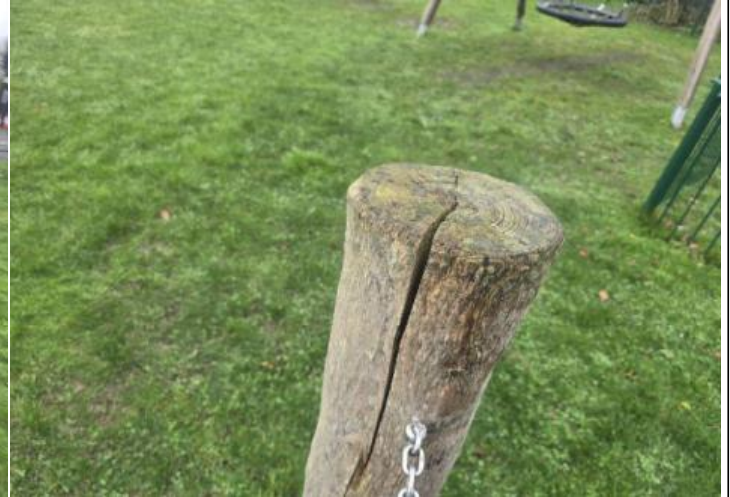
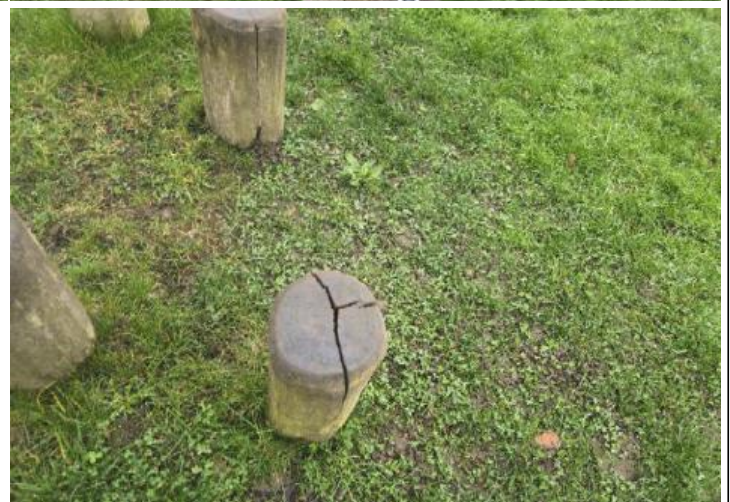
i 8 - Low Risk (Finding 1)

Item: Activity Equipment - Stepping Posts
Timber
Manufacturer: Kompan Ltd

Finding: There are splits running through the timber

Action: Monitor and ensure any rough or splintering edges are sanded down

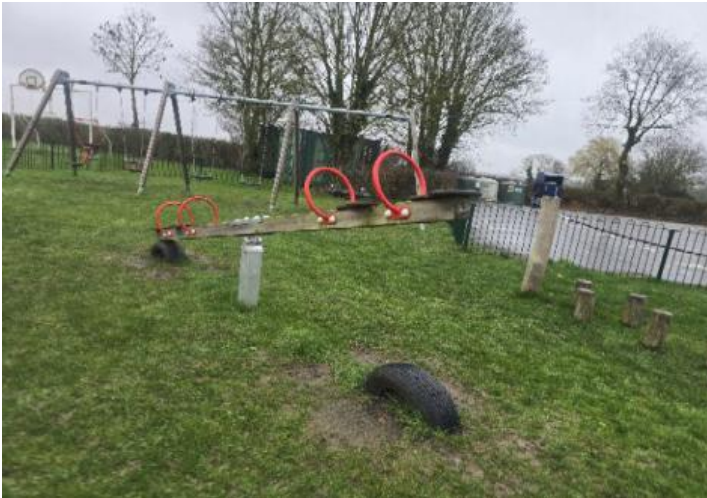
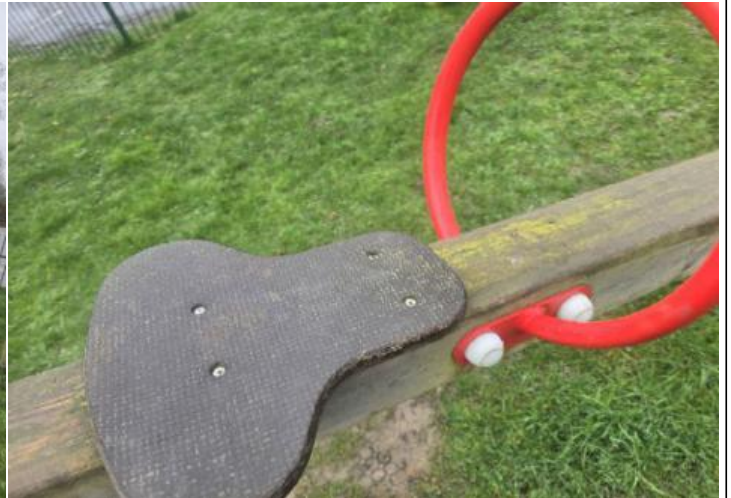
i 6 - Low Risk (Finding 1)

Item: Rocking Equipment - See Saw
Manufacturer: Kompan Ltd

Finding: There is algae or moss on the surface of the equipment

Action: Clean and treat appropriately

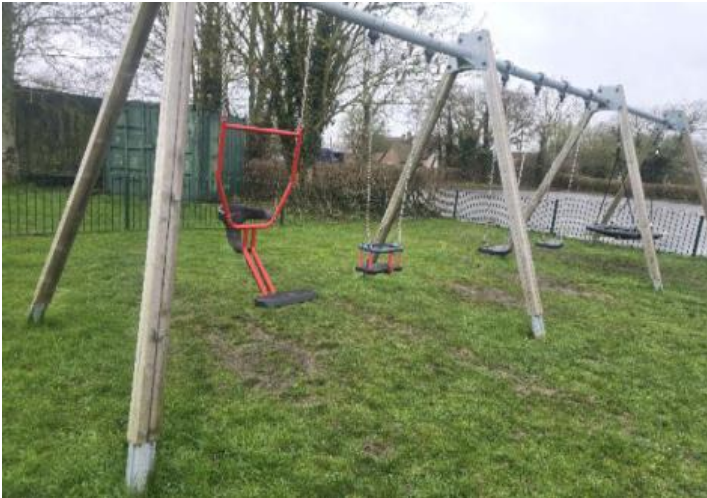
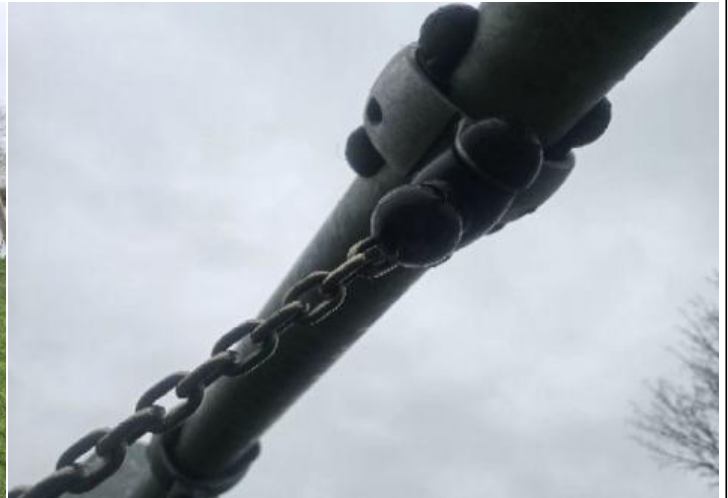
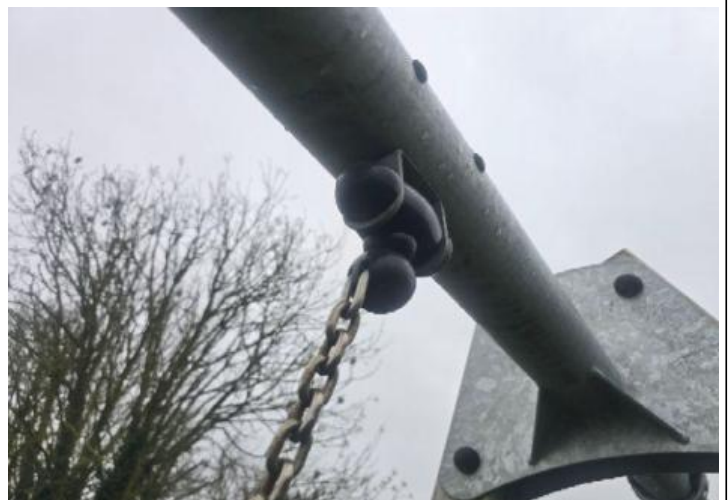
i 8 - Low Risk (Finding 1)

Item: Swings - 3 Bay Swing
Manufacturer: Kompan Ltd

Finding: The suspension lugs are showing signs of wear

Action: Monitor for any further deterioration and repair as required

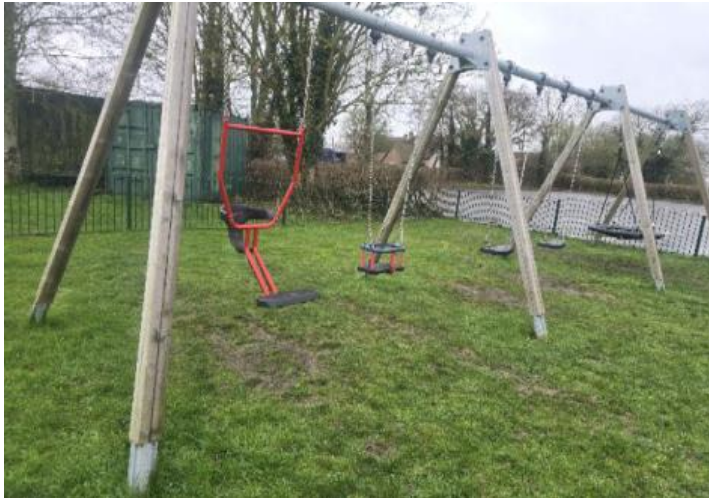
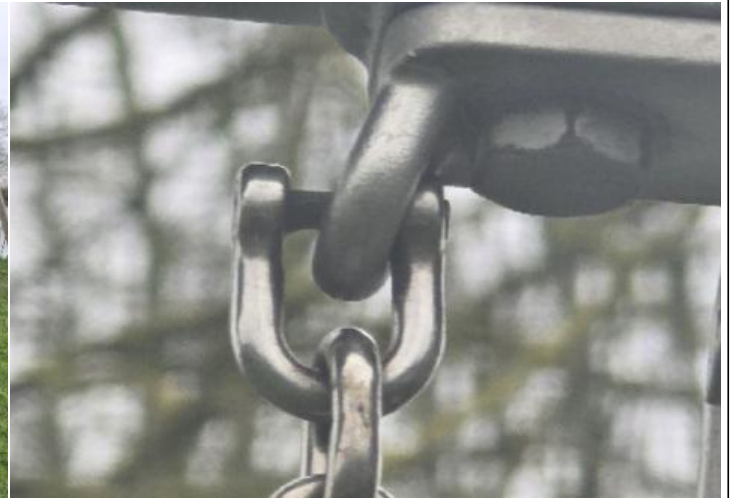
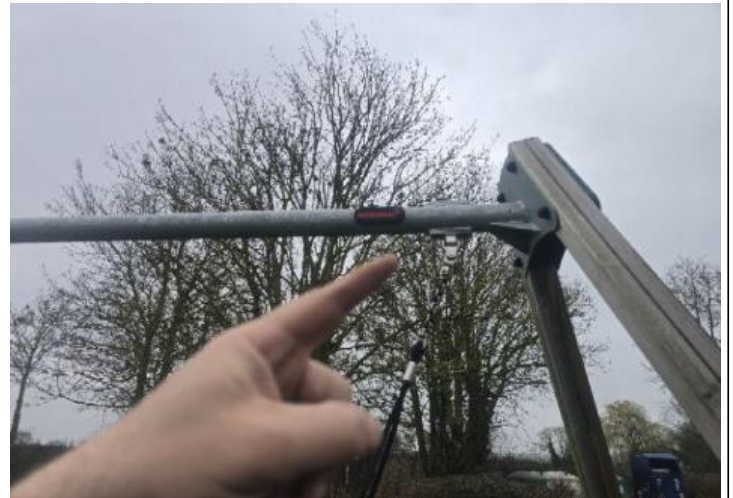
i 8 - Low Risk (Finding 2)

Item: Swings - 3 Bay Swing
Manufacturer: Kompan Ltd

Finding: The secondary safety shackles are worn in excess of 40% and require renewing **Action:** Replace worn shackles

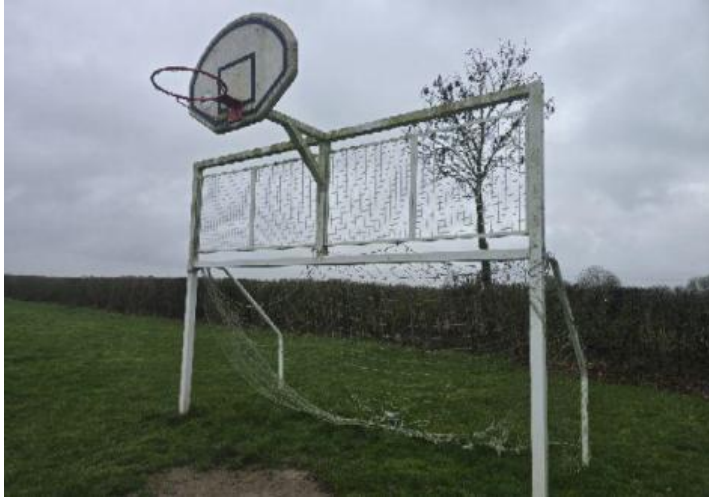
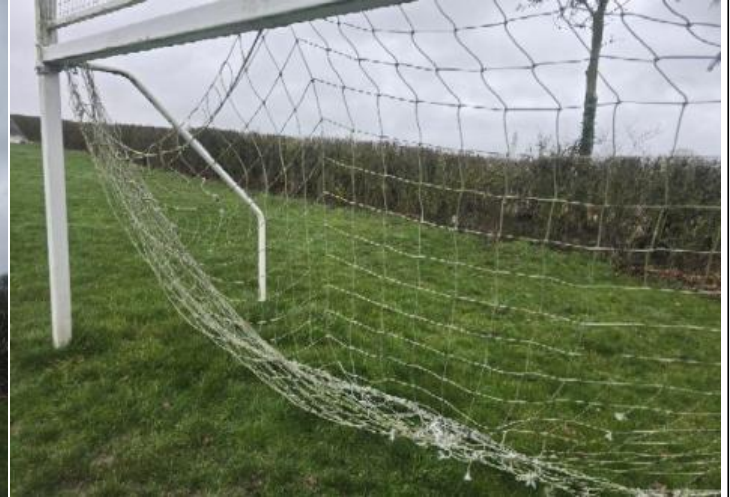
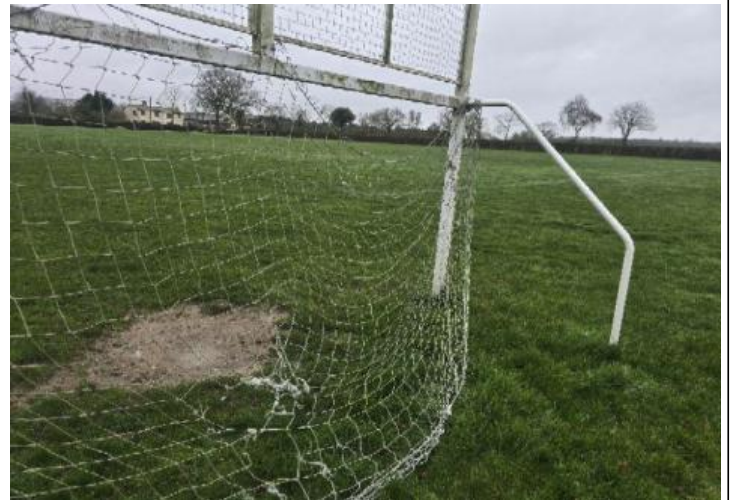
12 - Moderate Risk (Finding 1)

Item: Multi Use Games Area - Goalmouth and Basketball Post
Manufacturer: Not Identified

Finding: The net is damaged and requires removal / replacement

Action: Replace

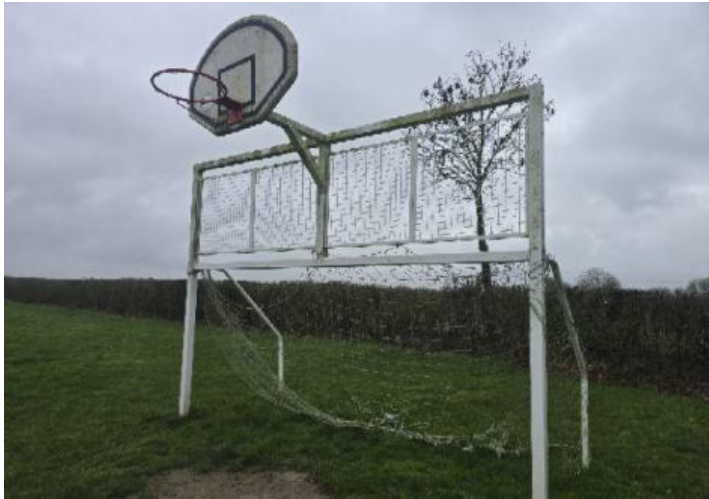
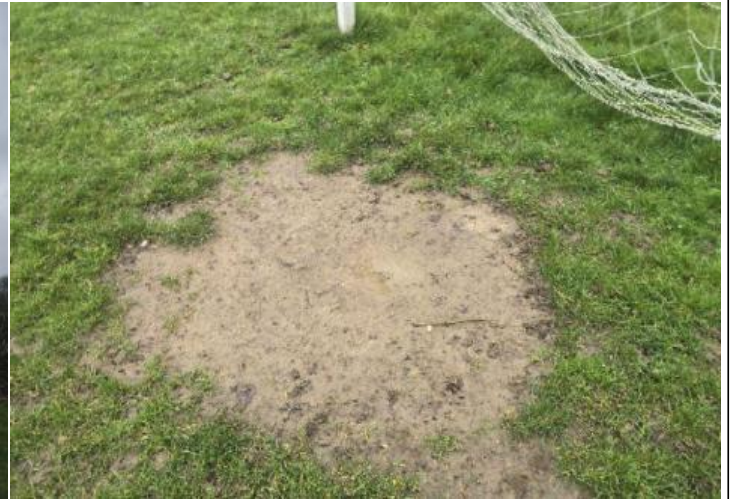
i 8 - Low Risk (Finding 2)

Item: Multi Use Games Area - Goalmouth and Basketball Post
Manufacturer: Not Identified

Finding: The area around the item has eroded and may become slippery

Action: Reinstate eroded area

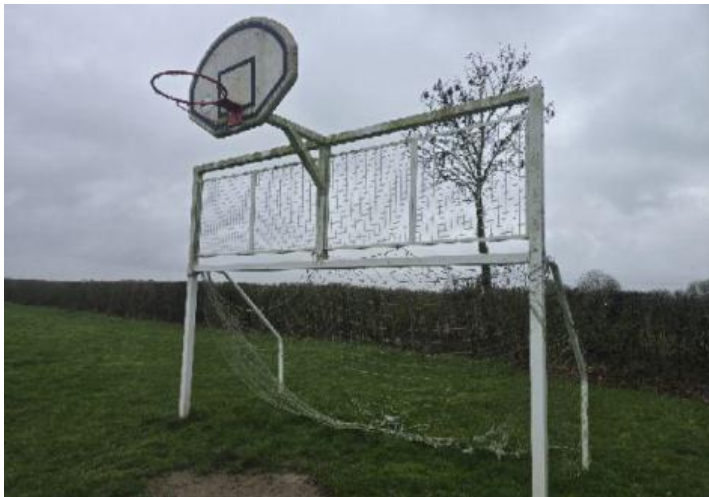
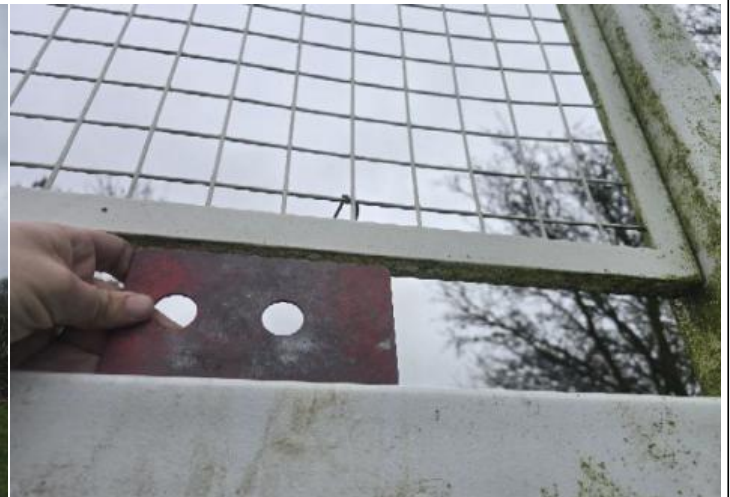
i 5 - Very Low Risk (Finding 3)

Item: Multi Use Games Area - Goalmouth and Basketball Post
Manufacturer: Not Identified

Finding: The item fails to meet the requirements of BS EN 15312 4.4.2.1 head and neck entrapment in the framework

Action: Monitor - No action given the risk assessment

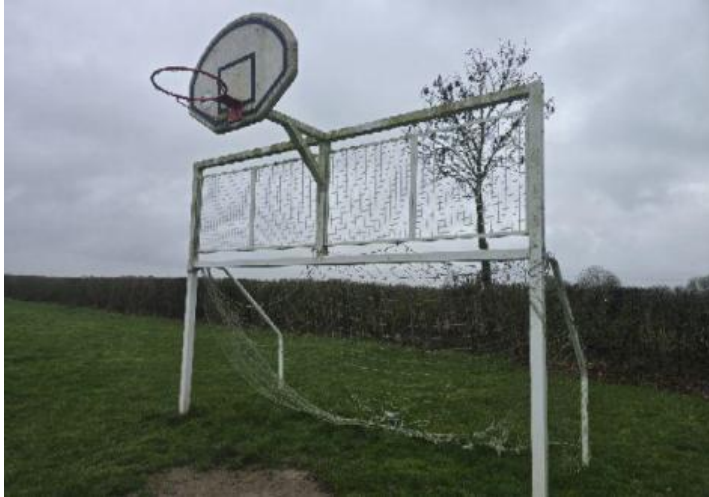
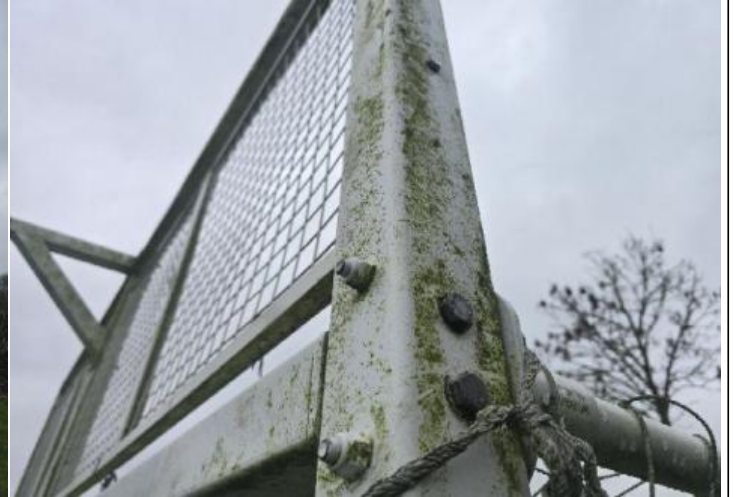
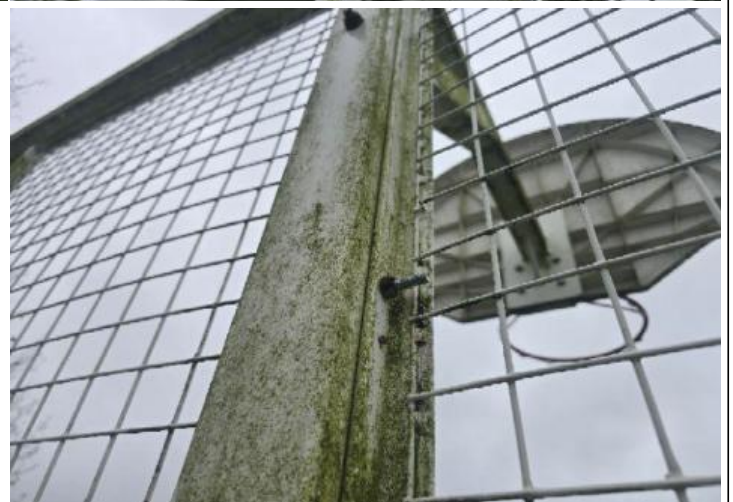
i 8 - Low Risk (Finding 4)

Item: Multi Use Games Area - Goalmouth and Basketball Post
Manufacturer: Not Identified

Finding: There are projecting bolt thread(s) present

Action: Remove excess thread length and deburr or provide cap

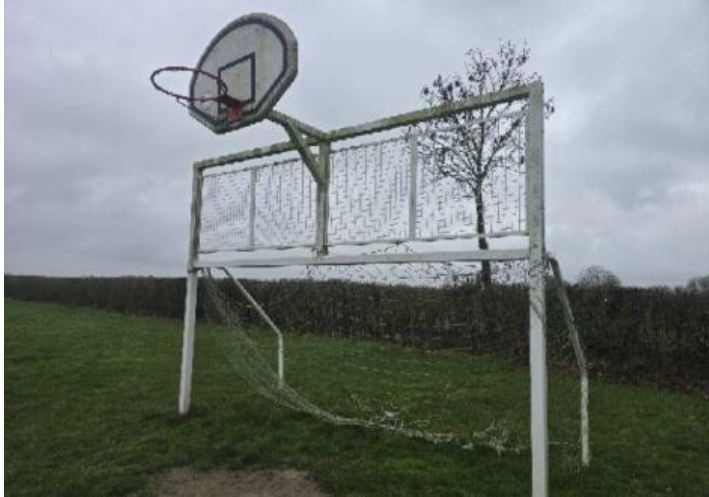
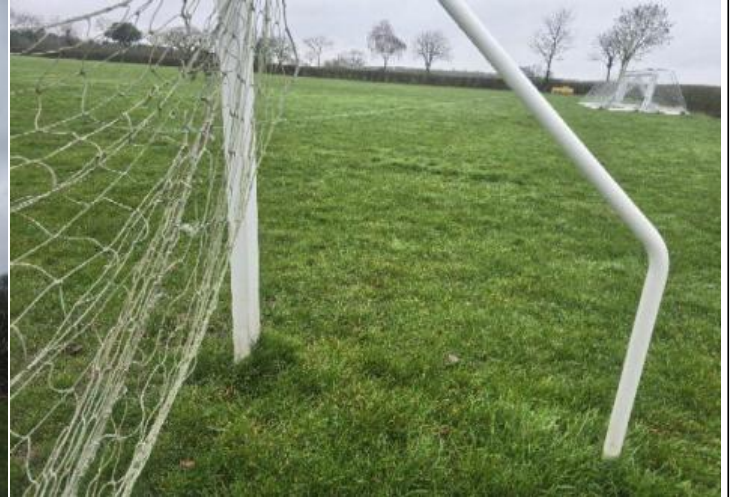
i 6 - Low Risk (Finding 5)

Item: Multi Use Games Area - Goalmouth and Basketball Post
Manufacturer: Not Identified

Finding: The item is slightly loose in its foundations

Action: Monitor for any further deterioration and repair as required

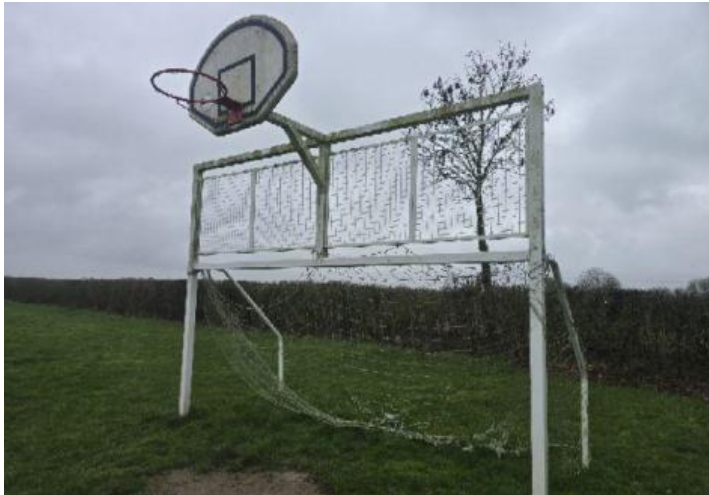
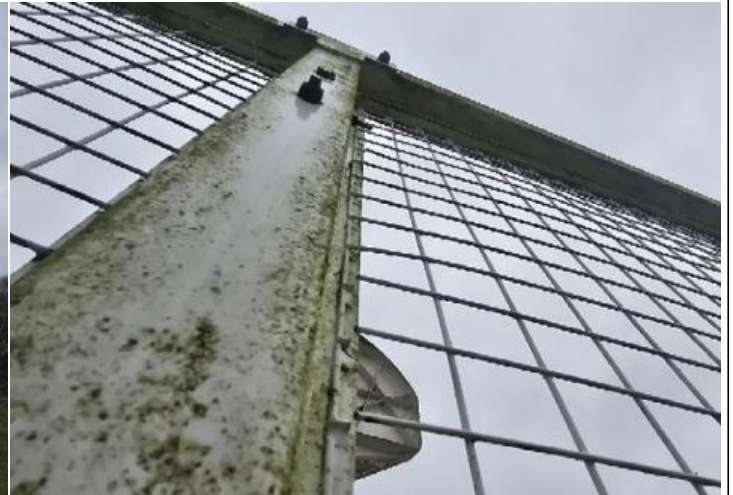
i 8 - Low Risk (Finding 6)

Item: Multi Use Games Area - Goalmouth and Basketball Post
Manufacturer: Not Identified

Finding: The weld(s) on this item have failed

Action: Repair item

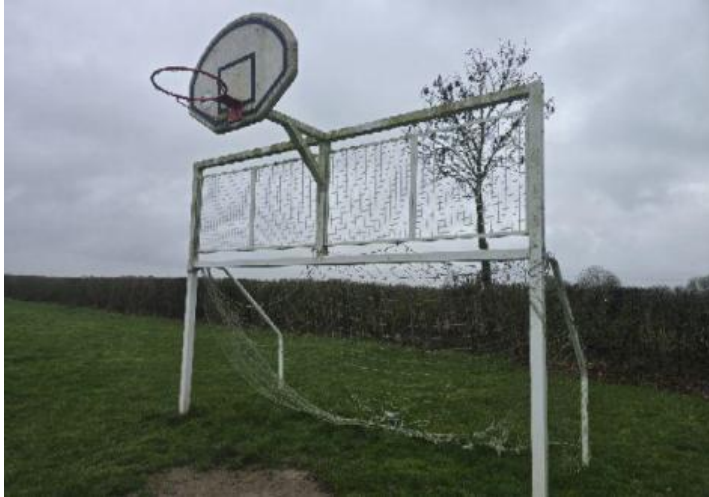
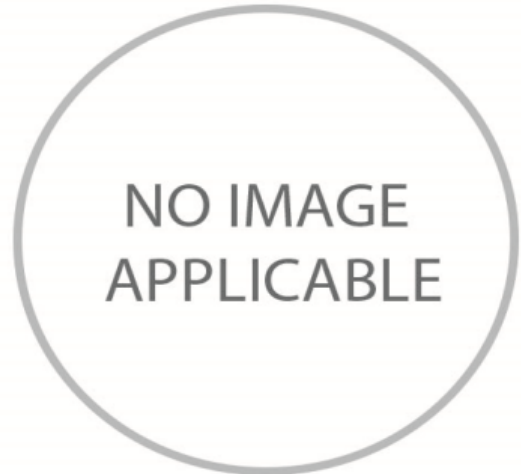
i 5 - Very Low Risk (Finding 7)

Item: Multi Use Games Area - Goalmouth and Basketball Post
Manufacturer: Not Identified

Finding: A clearly visible facility sign should be provided in a prominent position with the wording as detailed BS EN 15312- the equipment is not intended for children less than 3 years old- the warning - Do not climb on the framework or nets- the warning - Do not hang on the ring (if provided)- the warning - Do not wear rings or other jewellery- name and telephone number of the administrator- number to call in case of accident

Action: Provide signage to BS EN 15312

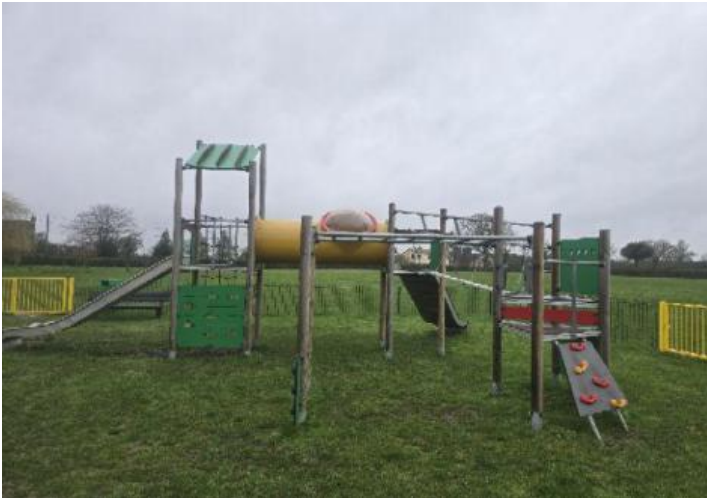
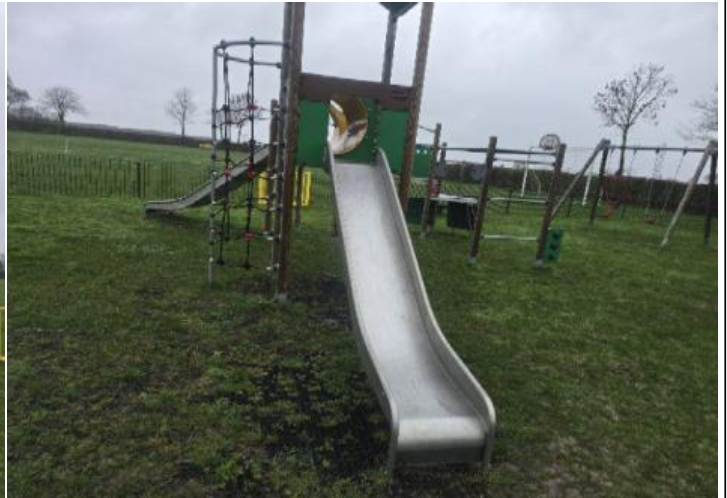
i 6 - Low Risk (Finding 1)

Item: Activity Equipment - Multi Play (Junior)
Manufacturer: Kompan Ltd

Finding: The slide is predominately south facing and will catch the majority of the sun's heat during the day. Slide surfaces can become very warm during periods of sustained sunny weather

Action: Monitor - No action given the risk assessment

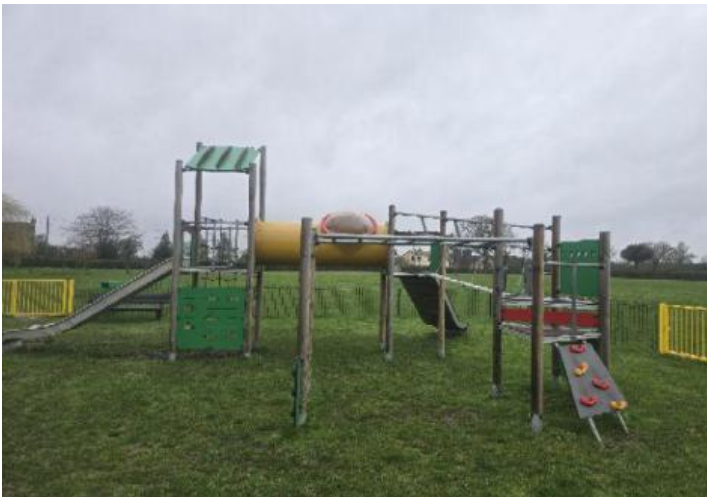
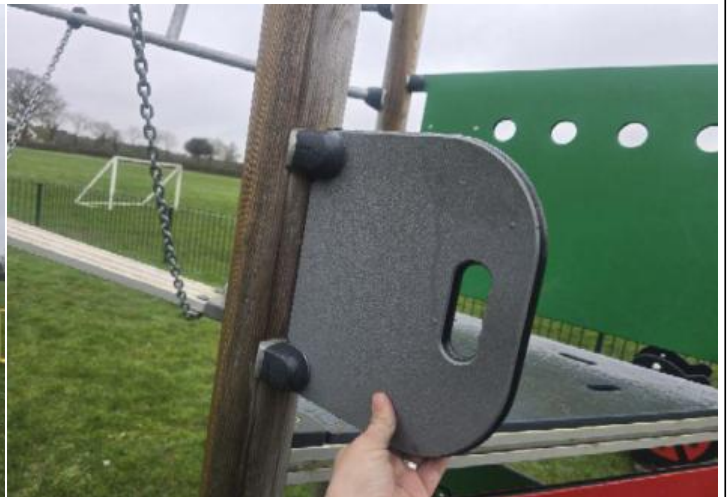
i 8 - Low Risk (Finding 2)

Item: Activity Equipment - Multi Play (Junior)
Manufacturer: Kompan Ltd

Finding: A number of fixing(s) have worked loose

Action: Secure all loose fixings
