## Annual Inspection

Mid Suffolk District Council

Ringshall Village Hall

Inspection Ref: 2297566

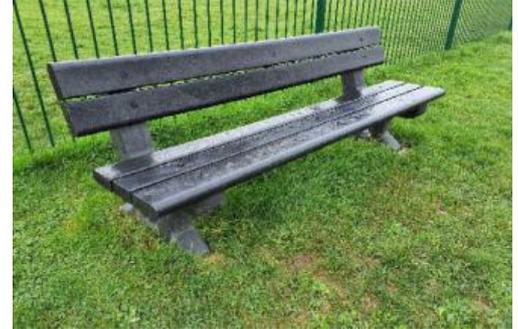
**Item:** Bench  
**Manufacturer:** Glasdon  
**Surface Type:** Grass  
**Item Quantity:** 2  
**Equipment Compliance:** N/A  
**Surface Area Compliance:** N/A

**Total Findings:** 1

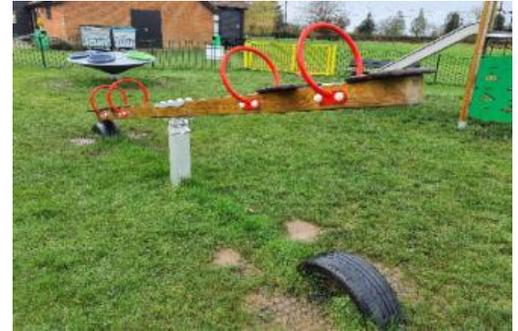
**Item:** See Saw  
**Manufacturer:** Kompan Ltd  
**Surface Type:** Grass Matrix Tiles  
**Item Quantity:** 1  
**Equipment Compliance:** Yes  
**Surface Area Compliance:** Yes

**Total Findings:** 1

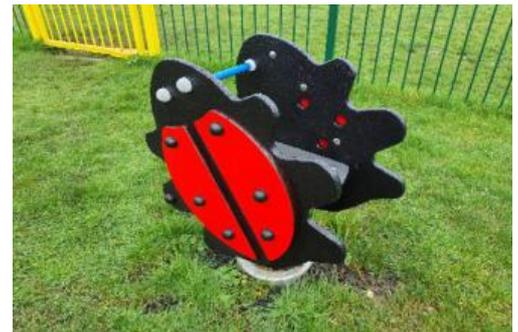
**Item:** Spring Ladybird  
**Manufacturer:** Kompan Ltd  
**Surface Type:** Grass Matrix Tiles  
**Item Quantity:** 1  
**Equipment Compliance:** Yes  
**Surface Area Compliance:** Yes

**Total Findings:** 1

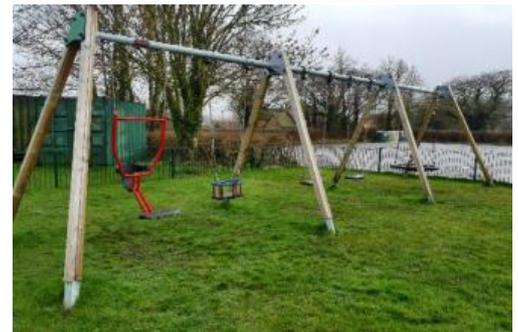
**Item:** 3 Bay Swing  
**Manufacturer:** Kompan Ltd  
**Surface Type:** Grass Matrix Tiles  
**Item Quantity:** 1  
**Equipment Compliance:** Yes  
**Surface Area Compliance:** Yes

This item is satisfactory - no work required -
