Annual Inspection

Mid Suffolk District Council

Ringshall Village Hall

Inspected: 2-March-2026 - 08:23 by James Law (RPII Annual Inspector)

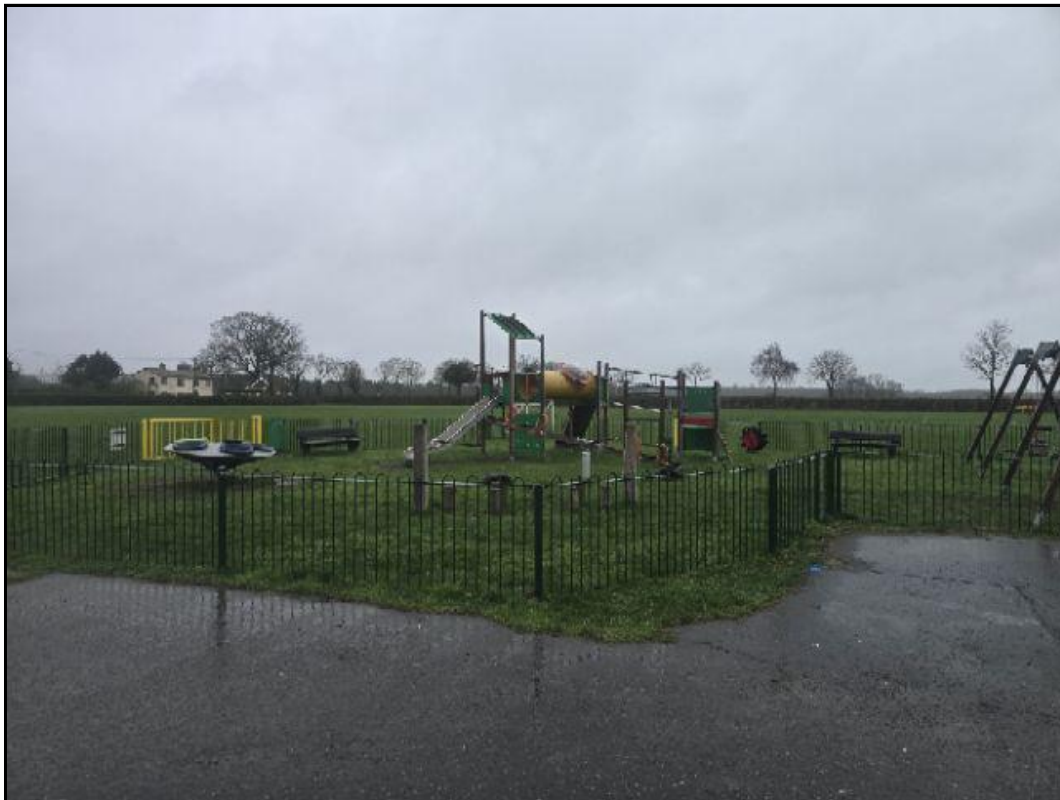
Risk Assessment: 12 Moderate Risk

The site is located in an area of public open space and is not directly overlooked by any properties in the local community.
